**CURRENT CREEK DAM TOE DRAIN REHABILITATION**  
**PROJECT ID: CEEN\_CPST\_010**

**A Capstone Project Final Report**

**Troy Ovard**  
**Central Utah Water Conservancy District**

**Department of Civil and Construction Engineering**  
**Brigham Young University**

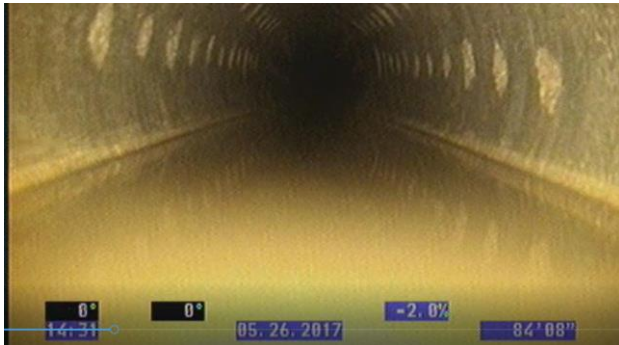
Currant Creek dam is an earthen dam with a damaged right toe drain. A video inspection of the pipe taken in 2017 shows problems with the drains including bellied sections and blocked/damaged portions (likely from the original construction of the dam). See Figures 1 and 2. The last 20 years of measured data also show almost no measured flow in the drain. Furthermore, piezometer data shows a steady increase in the elevation of the phreatic surface at various points in the dam within the dam over the past several years, likely due to the right toe drain issues. All this caused CUWCD to worry about the long-term stability of the dam and its ability to properly drain. They want to preemptively rehabilitate the toe drain to improve drainage.

*Figure 1: Bellied portion of pipe at 84' from downstream manhole*

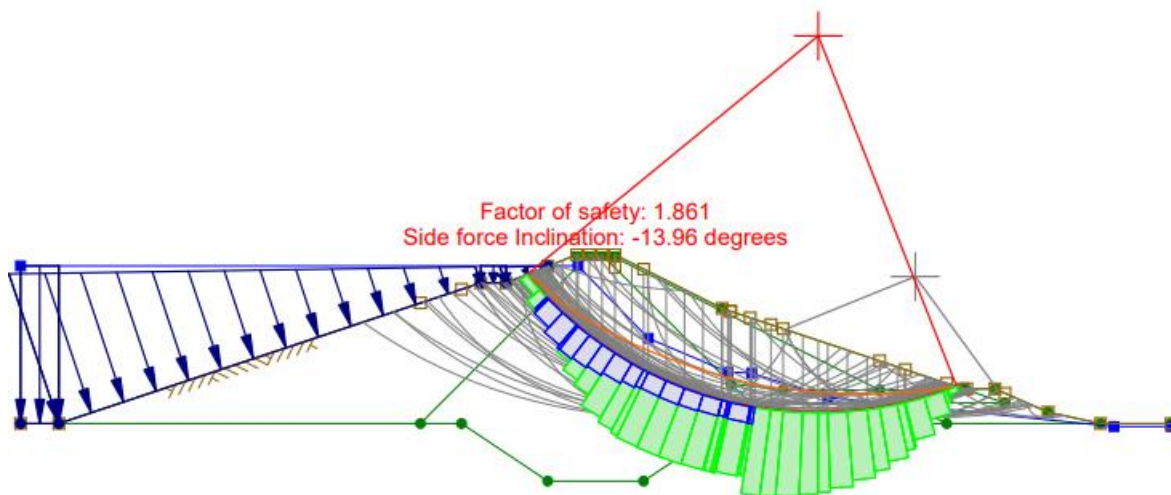
To determine a safe cut slope, cross sections of the dam at station 11+00 were analyzed through iterations of different cut slopes and locations. Spencer’s Method of Slices was performed using an educational version of UTexas4. The dam was first analyzed at the existing cross section without any cuts, which came out to be a factor of safety of 1.828. Then the different cut locations and slopes were iterated through. As specified by the USBR, the factors of safety needed to range from 1.2-1.8 to meet standard. An example of the UTexas4 outputs can be found in Figure 3. The cut slopes scenarios and resulting safety factors analyzed were simplified since UTexas4 outputs are not very legible and are shown in Figure 4. They can also be found in Appendix C as a part of the preliminary plan set.

*Figure 3 Current Creek Dam Slope Stability UTexas4 Output*

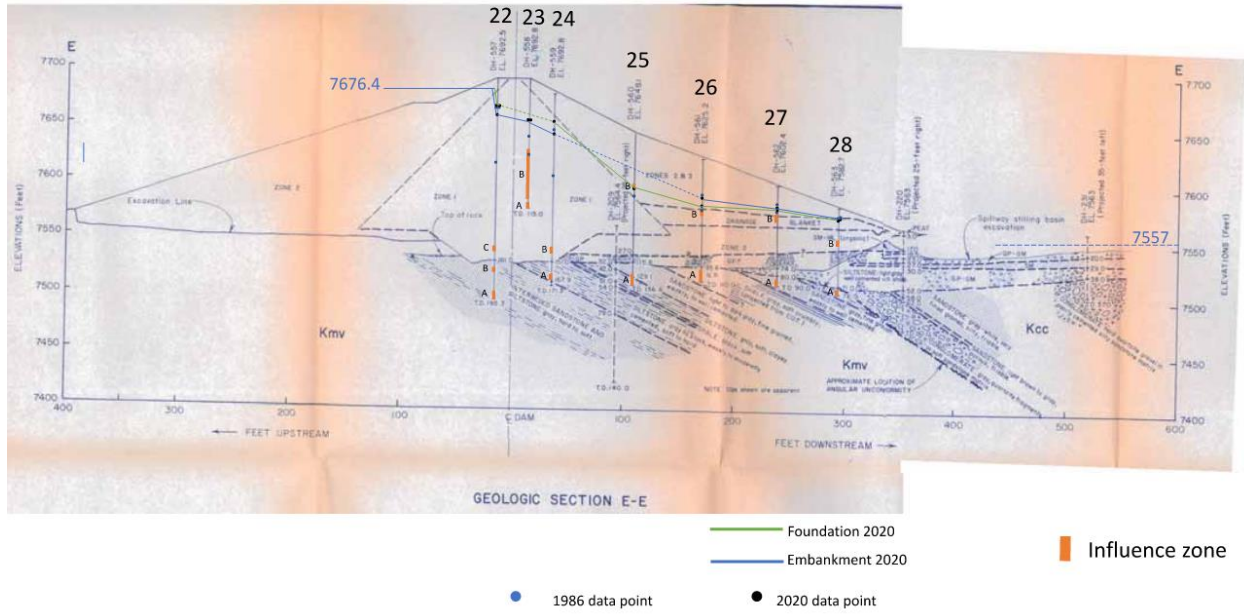
Figure 1: Phreatic surface at station 15+00

It appears that there are some drainage problems due to the rise in piezometers and inundation at station 15+00, and it is not recommended that the toe drain be left without remediation.

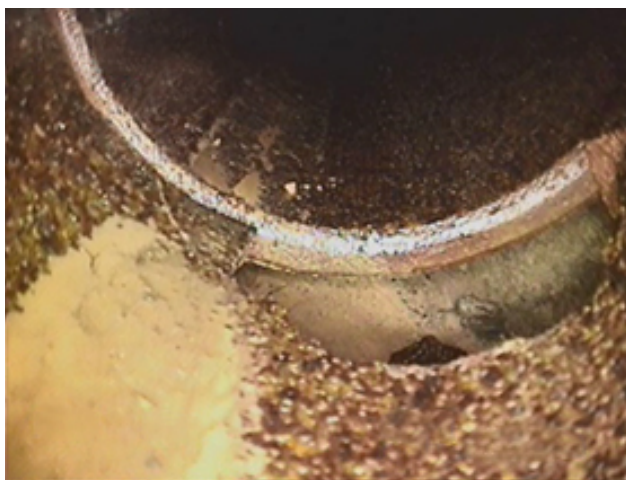
Photo 6 – View of a gap near the invert of a drain outfall, exposing the surrounding material.

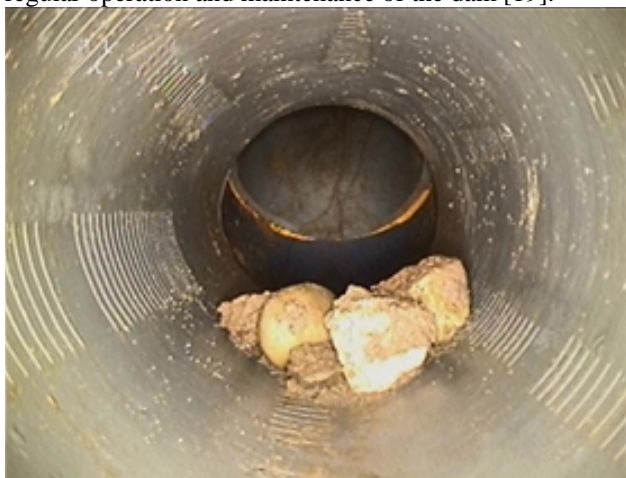
Photo 8 – View of gravel at the base of a cleanout, likely introduced during construction, creating a permanent obstruction for inspection equipment.

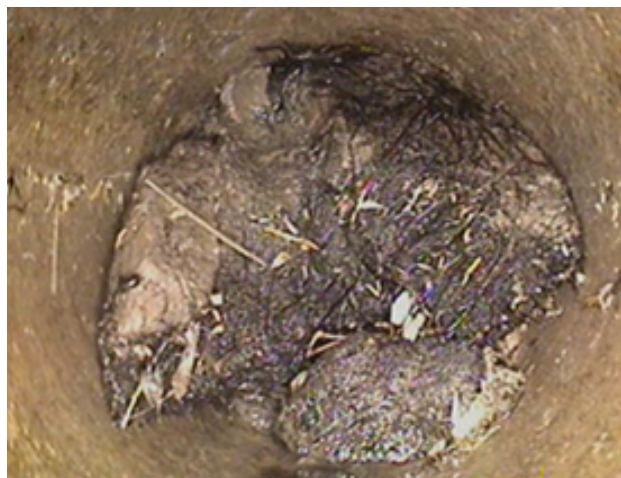
**Roots** - Roots from deep-rooted vegetation sometimes infiltrate toe drain systems, thereby limiting their effectiveness and inhibiting inspections (Photo 9). If root growth is not removed promptly when small, it can offset conduit joints, damage pipe, or completely obstruct the drain. If left for too long, it may require excavation and pipe replacement to be removed. As a preventative measure, deep-rooted vegetation within 25 feet of the drain alignment should be eradicated as part of the regular operation and maintenance of the dam [19].

Photo 9 – View of a root-ball completely plugging a drain.

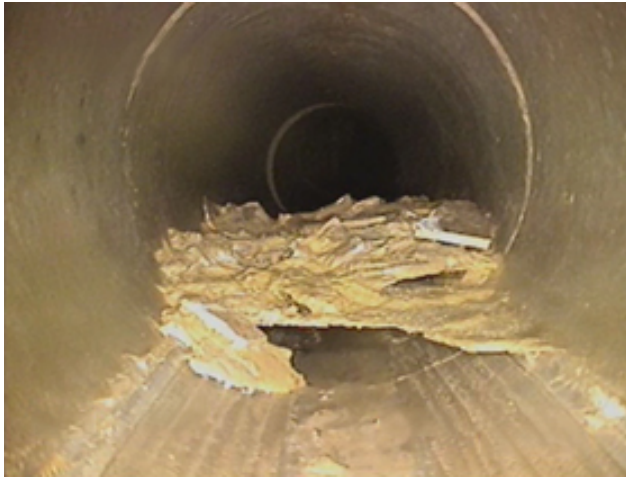
Photo 10 – Mineral encrustation created a permanent obstruction preventing inspection access.

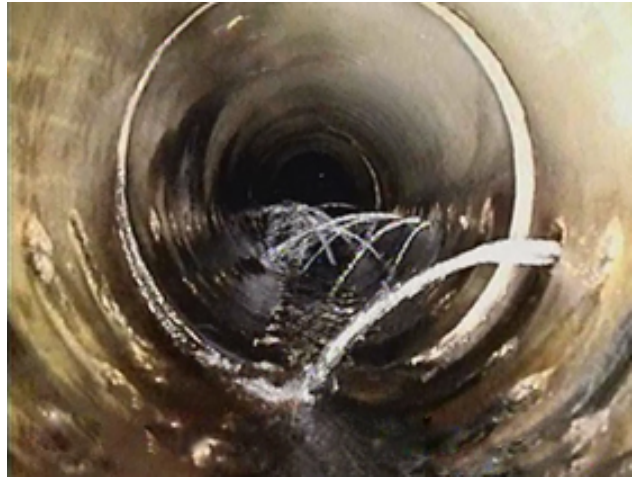
Photo 11 – Pressurized water entering through some of the perforations, while others are plugged up by sediment or mineral encrustation.

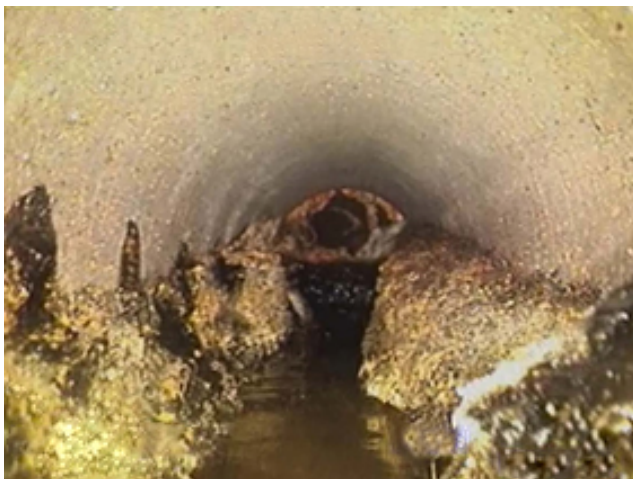
Photo 12 – View of biofouling along an abutment drain prior to cleaning.

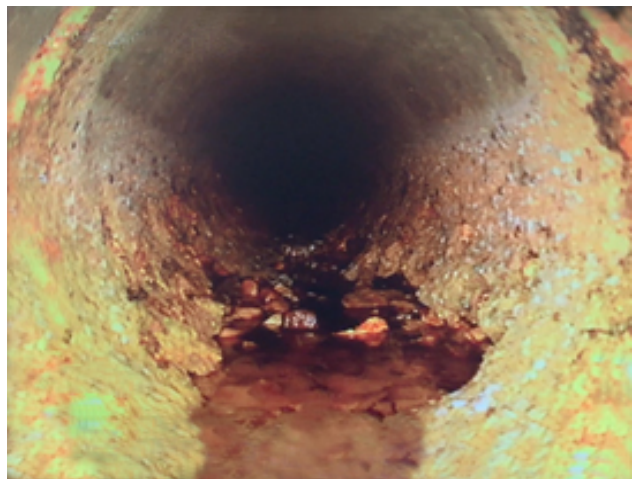
Photo 13 – View of a deteriorated invert of pipe, similar in location as that shown in Photo 12, after biofouling was removed.

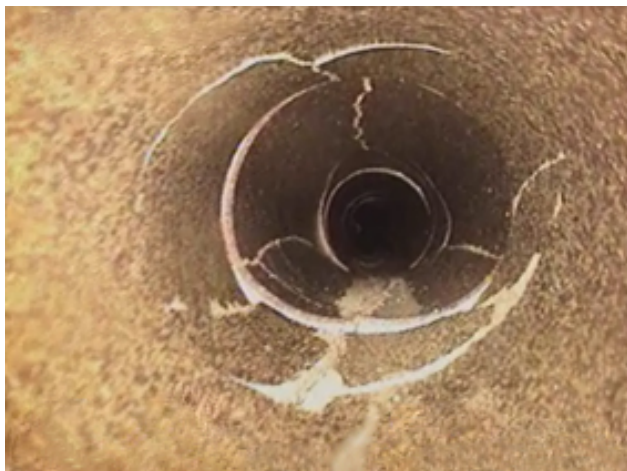
Photo 14 – Cracked clay-tile pipe.

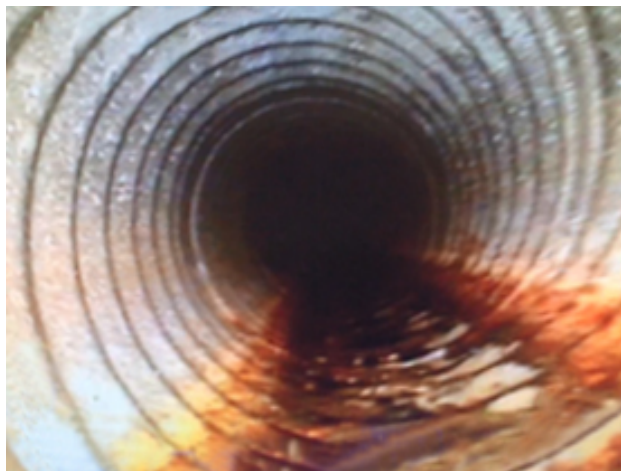
Photo 15 – View of corrosion on the invert of a toe drain which is allowing water to escape prior to discharging at the outfall.

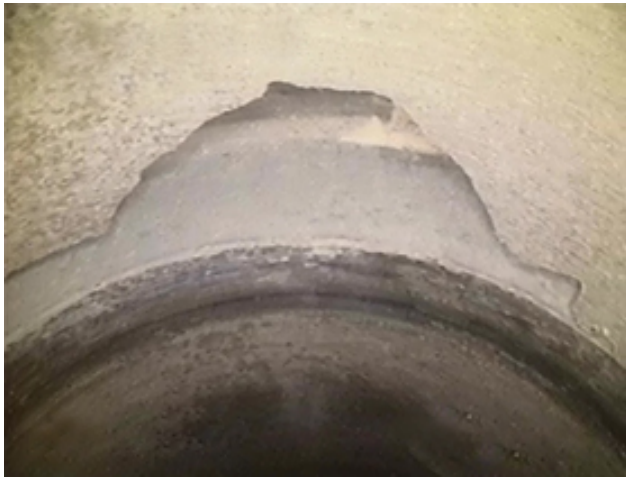
Photo 16 – Broken area near the crown of a bell-and-spigot connection between sections of concrete pipe, caused during construction.

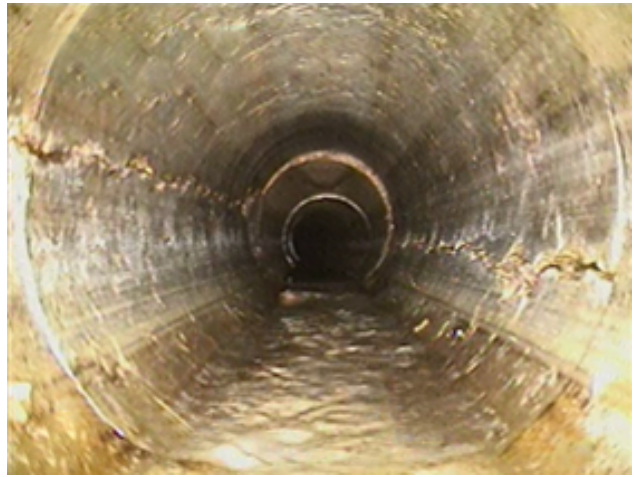
Photo 17 – View of longitudinal cracking in a concrete pipe, caused by overburden pressure.

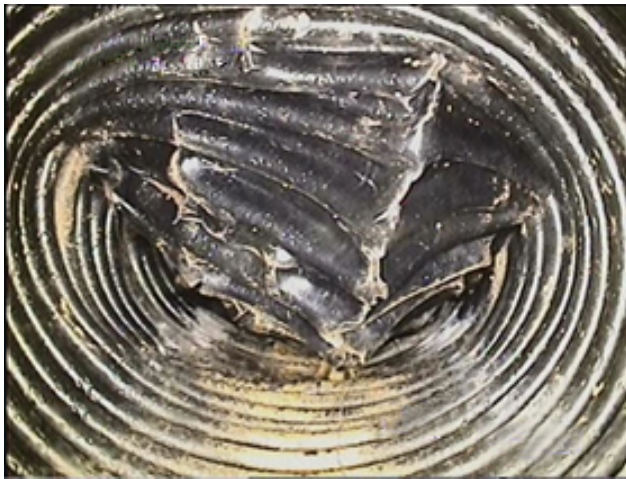
Photo 18 – View of a buckled corrugated HDPE drain pipe.

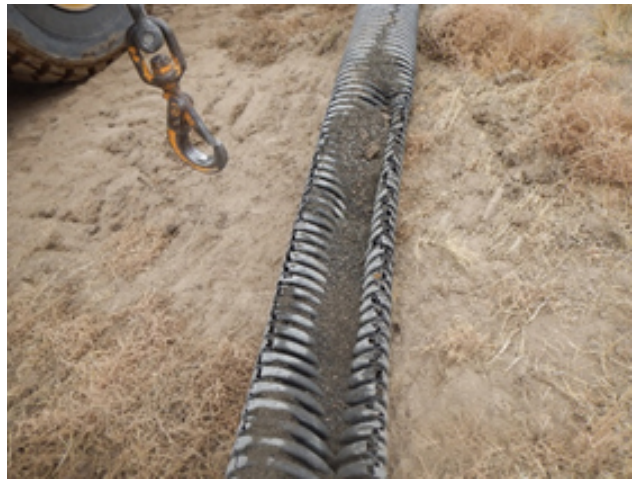
Photo 19 – View of a buckled corrugated HDPE drain pipe, likely caused from vehicular traffic traversing the drains.

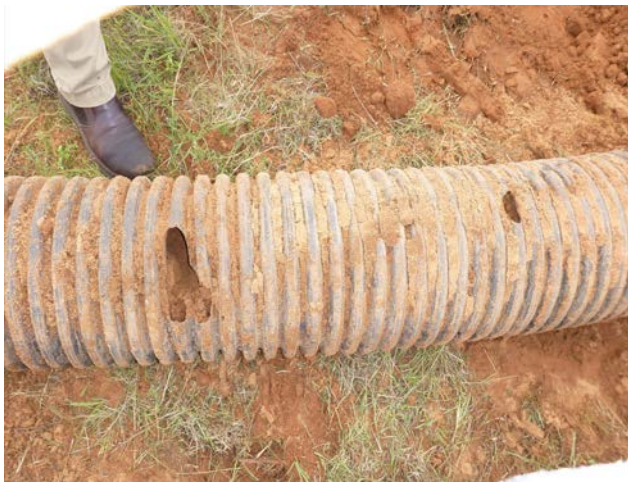
Photo 20 – View of holes caused by rodents burrowing through a single-walled HDPE pipe.

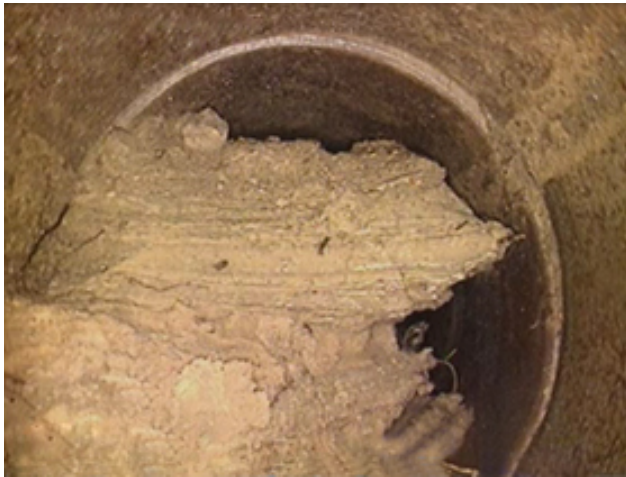
Photo 22 – View of a pipe that was completely full of sediment. Notice the stratification of sediment indicating that material movement and deposition has been occurring slowly over time.

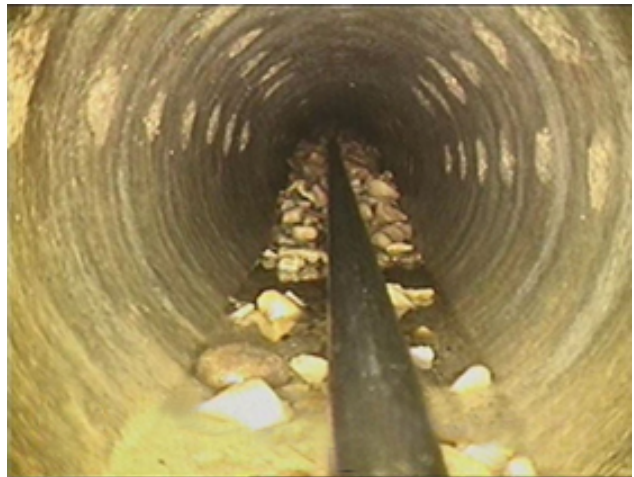
Photo 23 – View of a gravel pile in a 10-inch pipe that was large enough to completely lodge a jetter head, requiring mechanical extraction.

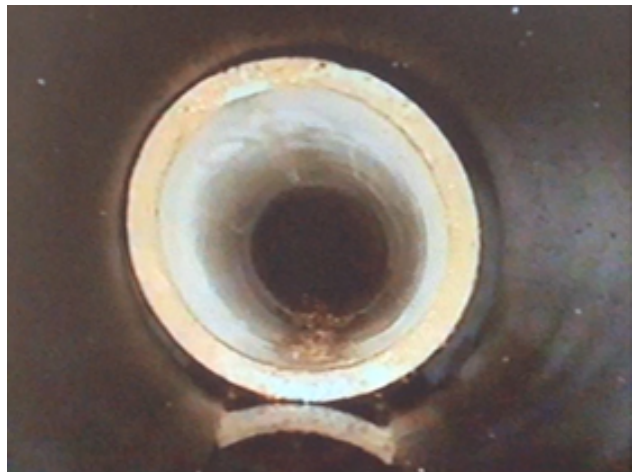
Photo 25 – View of the lip created by joining two concentrically-placed pipes, creating a permanent inspection barrier.

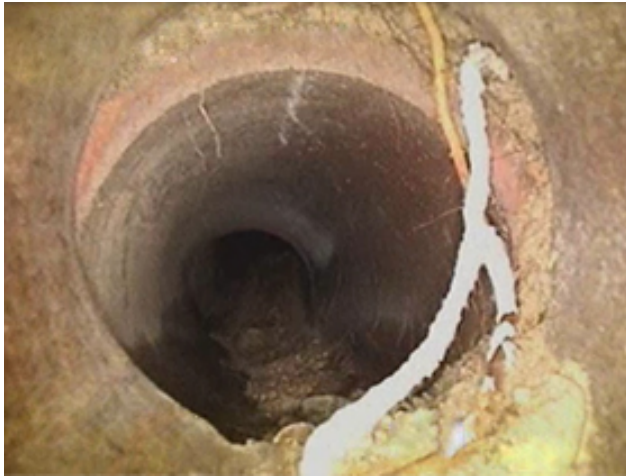
Photo 28 – Offset in a clay tile pipe which prevented further inspection of the toe drain.

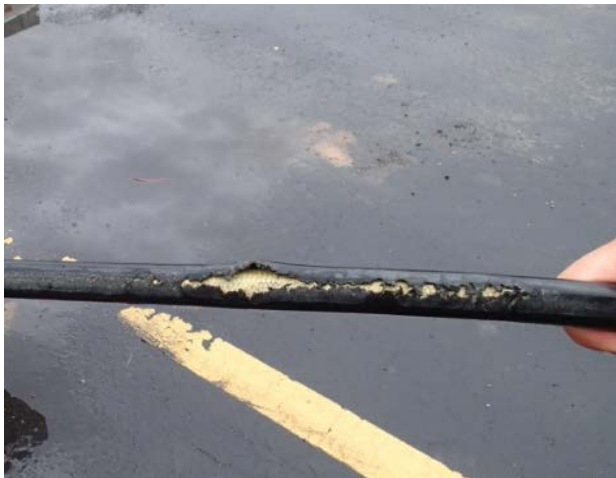
Photo 32 – Damaged cleaning hose from going around a sharp 90° elbow.

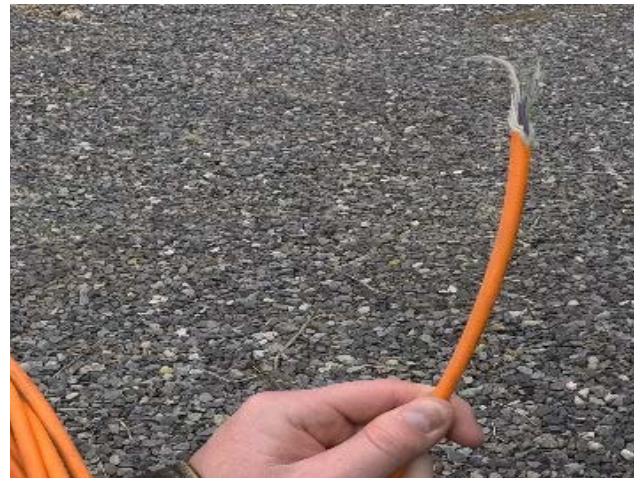
Photo 33 – A damaged CCTV cable caused by too much friction.

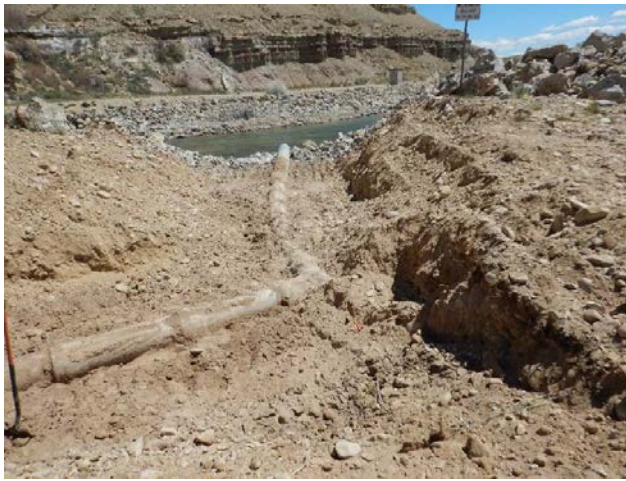
Photo 34 – A sharp bend in a toe drain outfall pipe which prevented inspection and cleaning equipment access.

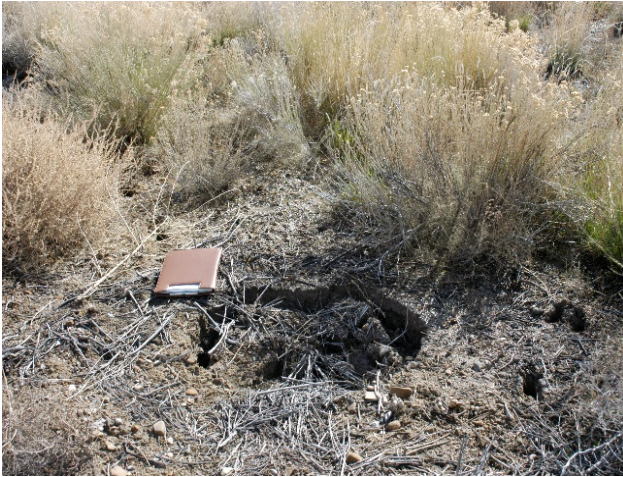
Photo 40 – View of a sinkhole which formed above a toe drain outfall pipe with large perforations and no filter.

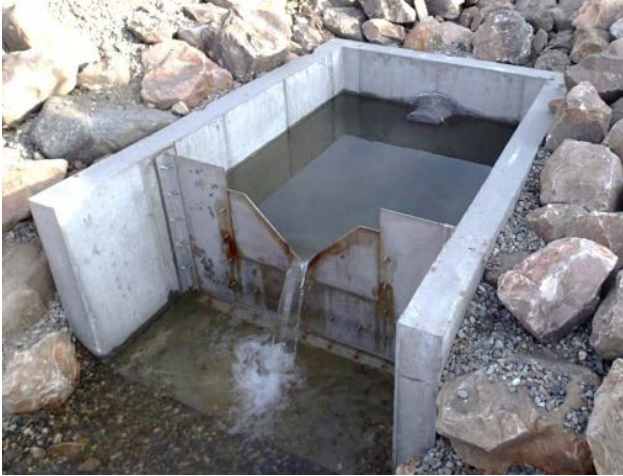
Photo 48 – View of water backed up into a toe drain system because of the measurement weir configuration.

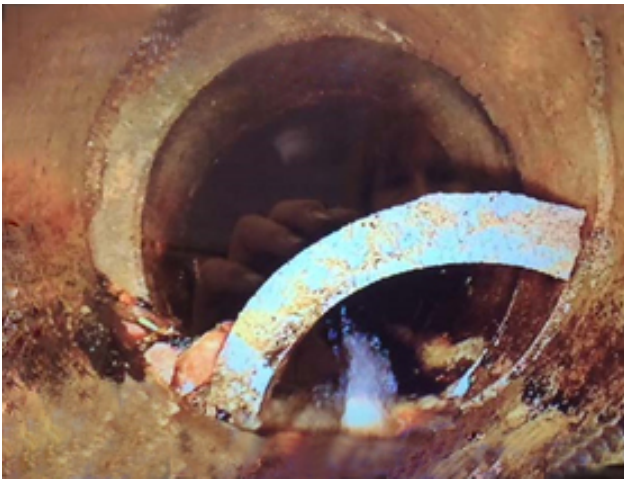
Photo 64 – View of a broken crown of a drain pipe that was lodged during modification of the toe drain.

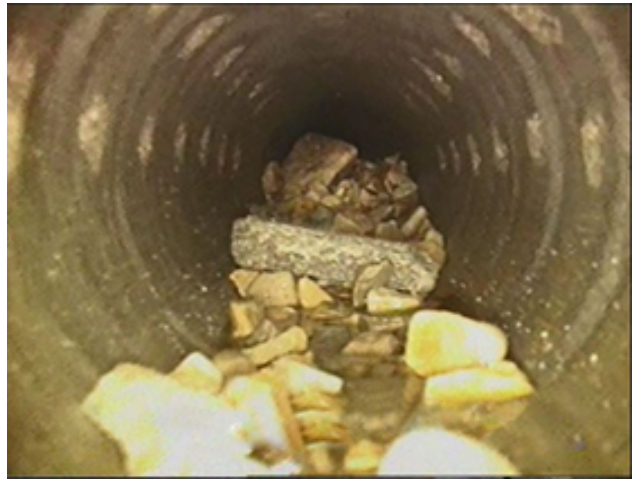
Photo 65 – Portion of crushed pipe and gravel sized material, blocking inspection.

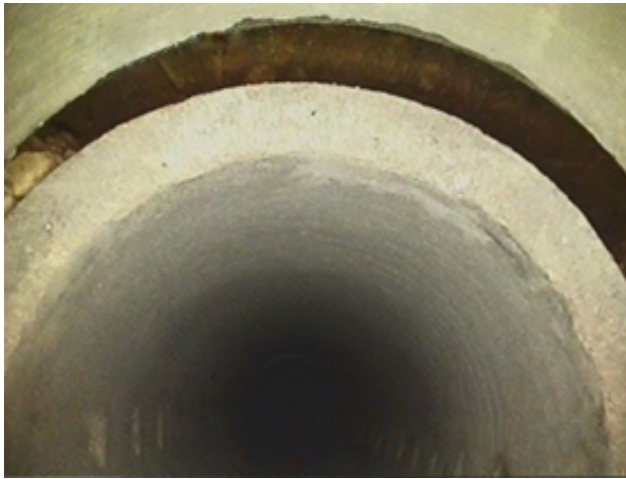
Photo 68 – View of a large joint opening through which overlying material had fallen, creating a void.

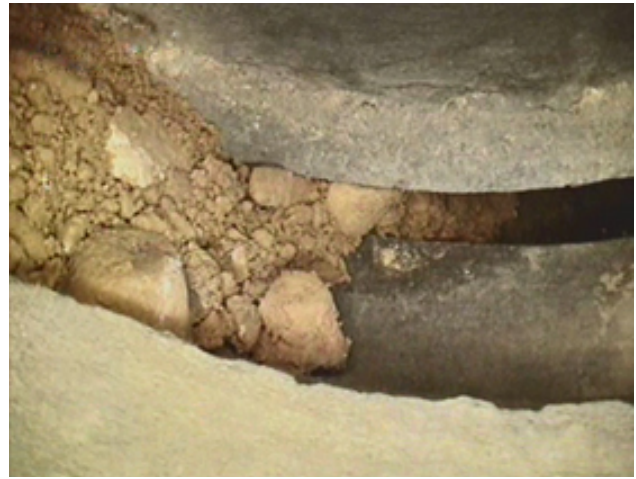
Photo 69 – View of material accumulated on the invert of the pipe due to another large joint opening.

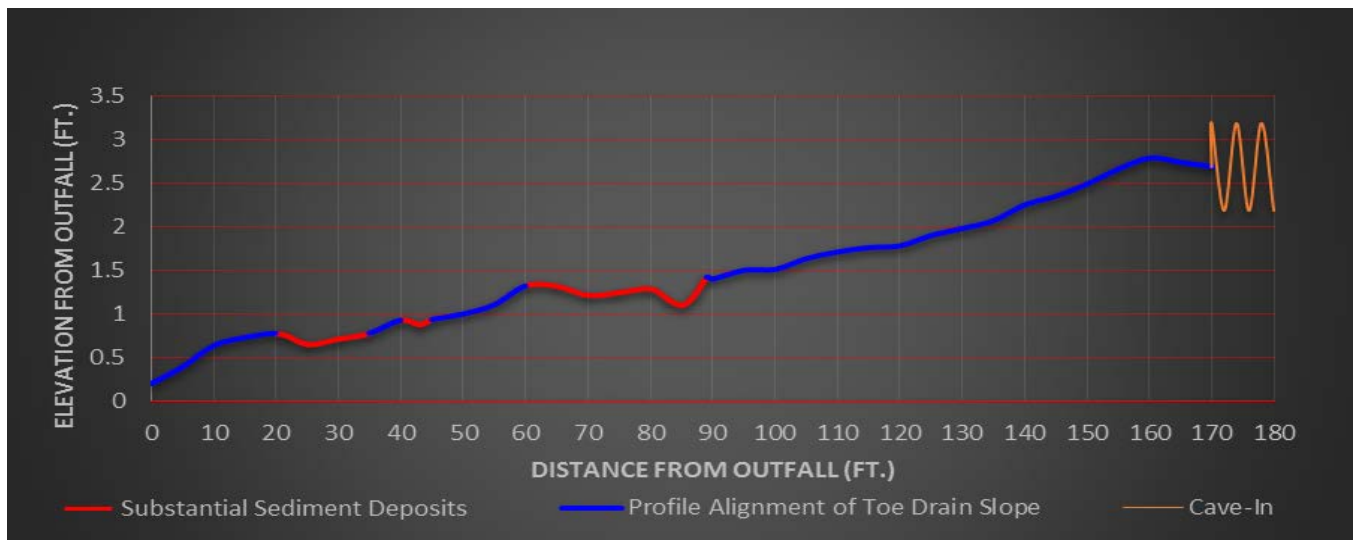
Figure 7 – Profile of a drain with sags which allowed sediment to accumulate and seepage to discharge through conduit openings prior to discharging (Photo 56 – Photo 61). The drain was never thought to be problematic as it had never been observed flowing.

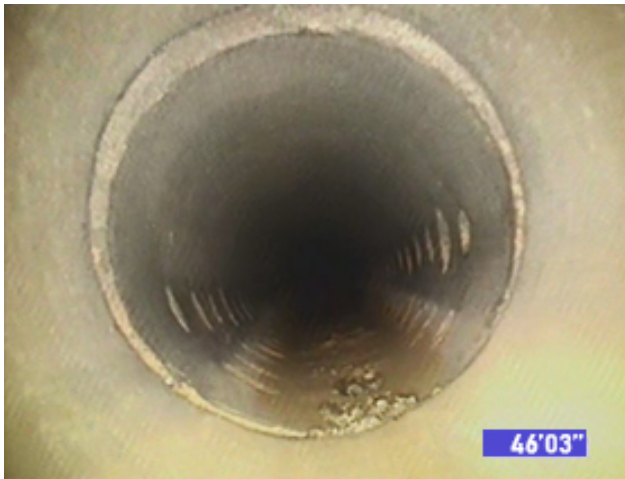
Photo 70 – View of a joint opening which allowed seepage to dissipate. Notice signs of water level in the upstream conduit.

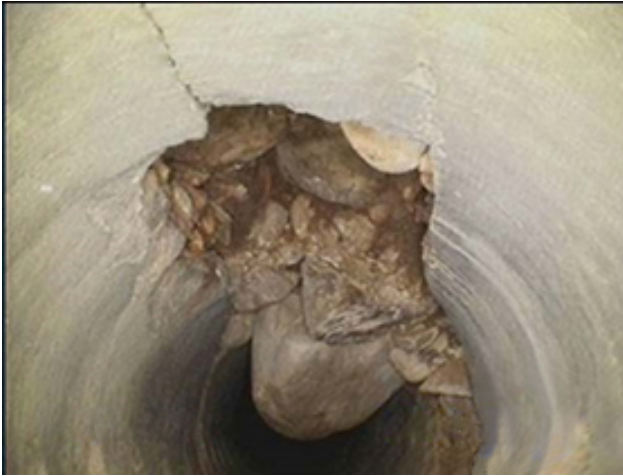
Photo 74 – Damaged crown of an outfall pipe that prevented inspection access of the toe drain.

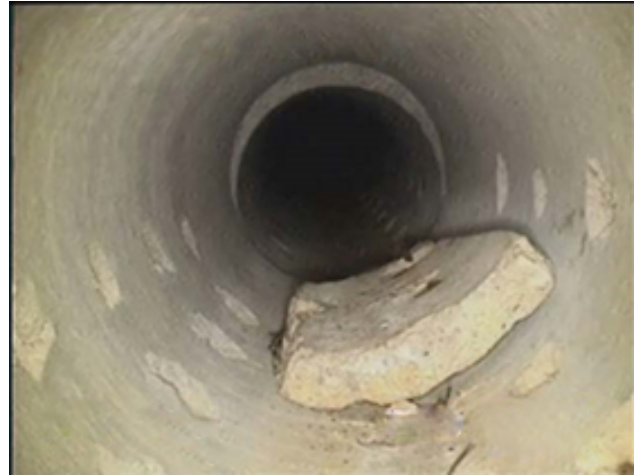
Photo 75 – View of a piece of a broken crown which permanently obstructed access.
