BLUFFDALE CITY ALTERNATE PAVEMENT METHODS
Project ID: CEEEn_CPST_003

A Capstone Project Final Report

Addison Mitton
City of Bluffdale

Department of Civil and Construction Engineering
Brigham Young University
April 17, 2024

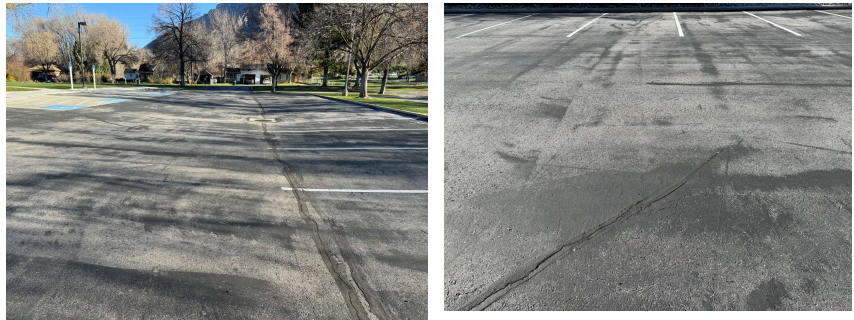
Figure 1.1.3: Site distresses

In 2014 this fiber reinforced asphalt was installed in Springville, Utah in a church parking lot. As pictured, the asphalt is experiencing extreme discoloration and longitudinal cracking, as is to be expected for a pavement in its tenth year. Seals have been applied to the pavement in order to extend its lifespan.

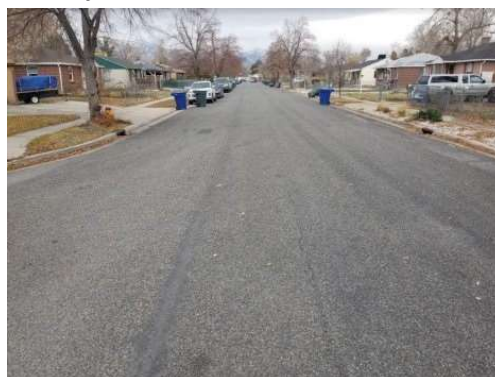
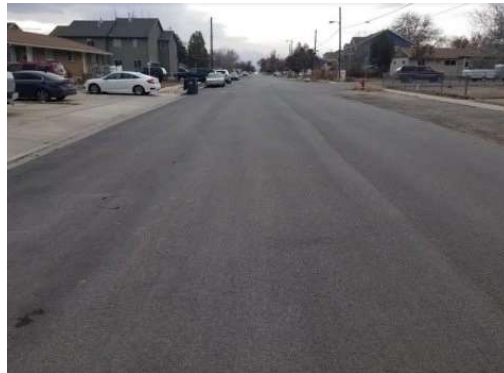
The two sites, displayed in figures 1.3.2 and 1.3.3, are two locations that have had FDR with cement installed. The site on Redwood Dr. was installed in 2008 and the site on 200 North was installed in 2020. Both roads are in incredible shape, and the bases are still displaying healthy strength. No information was procured concerning any overlays or treatments that have been done on Redwood Drive since the FDR with cement installation. However, the road has not had to undergo any major reconstruction. The site on 200 N is still in its prime years, displaying no fatigue, cracking, or external wear.

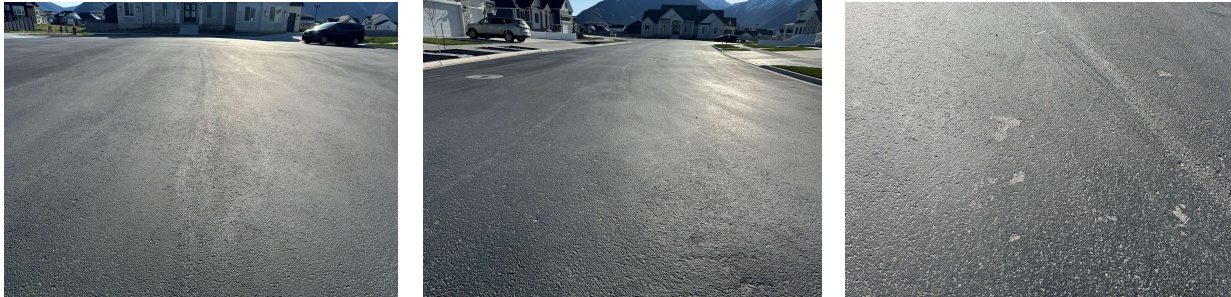
Figure 1.4.2: 700 N 800 W in Mapleton, UT treated with HA5

700 N 800 W. This new construction road was treated with HA5 in 2023 by Holbrook Asphalt. It is a residential road and cul-de-sac, meaning that there is no through traffic. These factors, along with the HA5 have led to virtually no wear on the road. No other treatments have been applied to this segment. According to HA5 claims, this road should have around 7 years left before other pavement treatment methods are required.

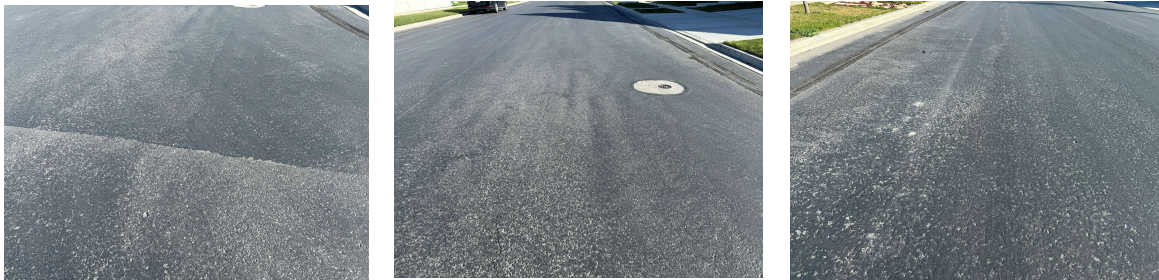
Figure 1.4.3: 700 W in Mapleton, UT treated with HA5

700 W South of 1200 N. This site was treated with HA5 by Holbrook Asphalt in 2021. It is a residential road with limited through traffic. At the intersection, it was clear that the HA5 treated road segment has maintained its color better than the road to the south (1000 N). In the wheel path, there is beginning to be some discoloration and graying. The road is fully operational with no seals or other pavement treatments being visible on the road's surface, except for seals regarding fiber or cable installation (pictured right). Some longitudinal cracking below the surface can be seen. The asphalt has not fully cracked, but it seems there is structural damage to the road.

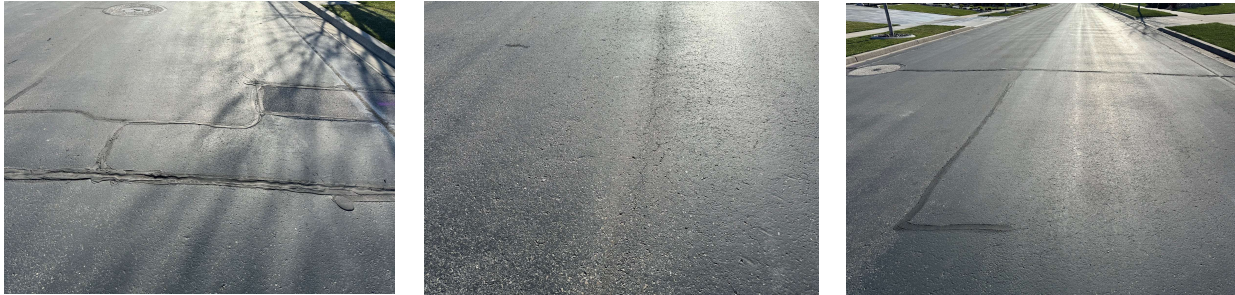
Figure 1.4.4: Fallen Leaf Drive in Mapleton, UT treated with HA5

Fallen Leaf Drive between 600 W and Mountain View Lane. This residential road was outfitted with HA5 in 2015 by Holbrook Asphalt. The road experiences limited through traffic. The pavement has been treated with a crack seal treatment in several spots. Most treated areas are experiencing transverse cracking. As with other segments assessed, several of the areas are experiencing damage because of sawcuts used to install underground utilities. The pavement surface requires a new treatment, either HA5 or a different prevention method.

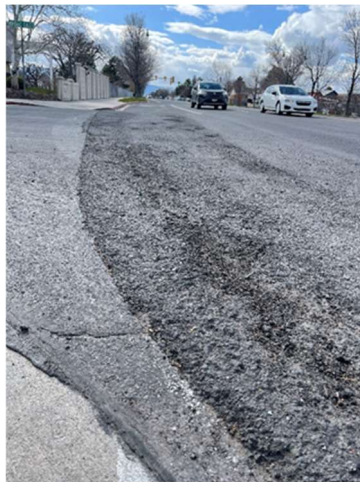
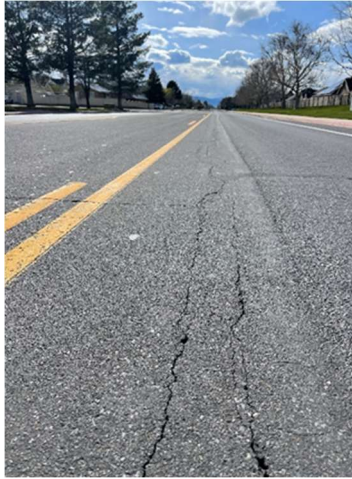
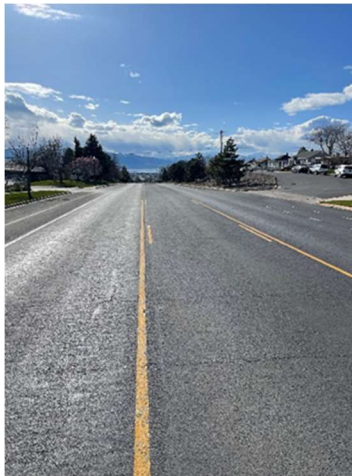
In Orem, the application of microsurfacing treatments over recent years offers valuable insights into the practical performance of this pavement maintenance method. The comparison between roads treated in 2016, which have shown visible signs of deterioration requiring patching (Figure 1.5.1), and those treated more recently, where only minor patching and crack sealing were needed (Figures 1.5.2 and 1.5.3), illustrates the range of durability and effectiveness microsurfacing can achieve.

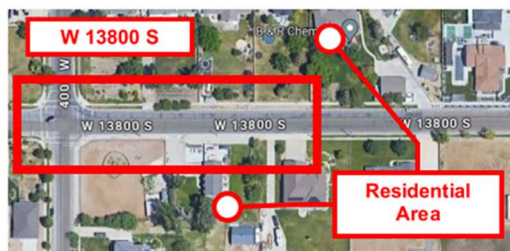
Figure 2.1.1: Aerial View

The roadway at W13800 S resides in a low-traffic residential area, presenting an excellent condition with a PASER grade of 9. This denotes a surface with no imperfections such as cracks, raveling, or any form of distress, indicating a recent successful overlay. However, to mitigate future deterioration predominantly caused by sun exposure, proactive pavement preservation measures are essential.

Given the low traffic intensity and environmental considerations, the implementation of a Type I Slurry Seal or HA5 treatment is recommended within the next three years. The decision between these two methods should be based on a detailed project-level analysis, with Type I Slurry Seal offering cost-effectiveness and HA5 providing superior durability and protection against environmental factors. Consideration of potential issues such as thermal coefficient-related cracking in HA5 is crucial.

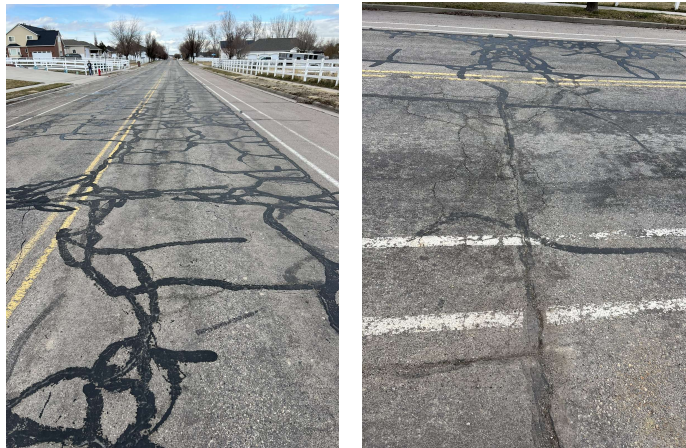
Figure 2.2.2: Site distresses

The site was assigned a Paser 3 category (poor) due to its deteriorated conditions, closely spaced transverse cracks often showing raveling and crack erosion. Extensive alligator cracking (more than 25% of surface) with patches in fair condition. Moderate rutting or distortion (1" or 2" deep). More than 25% of the surface exhibited alligator cracking, indicative of extensive distress. The extensive transverse cracking can be a high concern as it may result in base layer failures. At a network level, road segment W13800 S 4000 W is due for at least a milling of asphalt overlay. If no further damage is found to subgrade, the roadway can be repaved for further use. If cracks are found further into subgrade, further testing and analysis will be needed to determine best options for the roadway segment.

Considering observed extensive fatigue cracking and the extensive use of crack seal, full depth reclamation with cement (FDR), followed by edge milling to maintain the existing elevation along the lip of a gutter. This approach is suitable for extensive structural repair, and a project-level analysis should be undertaken to ascertain if a more comprehensive solution such as complete asphalt removal and reconstruction is warranted.

Considering observed extensive fatigue cracking, the report recommends full depth reclamation (FDR), followed by recompaction as an effective remediation strategy. Edge milling may need to be performed, especially to maintain the existing elevation along the lip of a gutter. This approach is suitable for extensive structural repair, and a project-level analysis should be undertaken to ascertain if a more comprehensive solution such as complete asphalt removal and reconstruction is warranted.

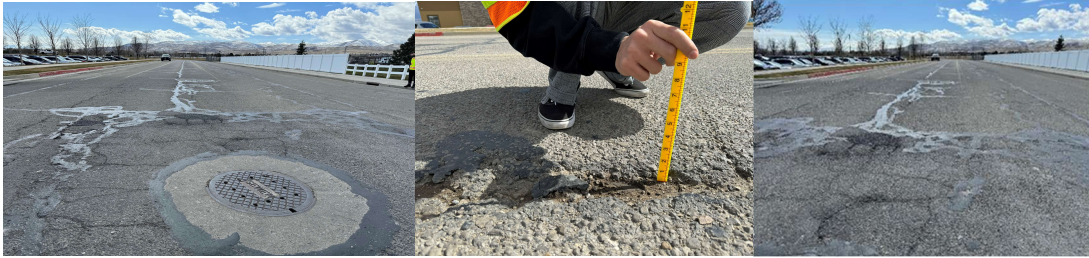
Figure 2.3.2: Road distresses

The site, classified as Paser 2 (very poor), shows significant road deterioration, posing substantial risks to road users. Over 25% of the surface features alligator cracking and severe distortions deeper than 2 inches, which undermine the road's structural integrity. Poorly patched areas and potholes are prevalent, especially around a centrally located manhole. These conditions, worsened by nearby construction and proximity to a school, severely affect traffic flow and increase accident risks. Figure 2.3.2 illustrates the road's poor condition with images of the extensive damage.

Given the extensive damage observed at Site 3, a full depth removal process is recommended. This method entails the excavation of the existing pavement down to the base, ensuring the removal of all damaged materials. Subsequently, the area is reconstructed with new base materials and surfaced with fresh asphalt. Although this approach incurs higher costs, it is essential for ensuring long-term durability and safety. This strategy is crucial for addressing the underlying structural issues comprehensively.

The recommended course of action for Site 3 (13800 S 2950 W) is a full depth removal, involving the excavation of the existing pavement down to the base and the removal of all damaged material, to then replace the asphalt with a new base and fresh asphalt layers. This process is crucial for significant structural improvements and restoring the long-term durability and safety of the roadway, given its extensively deteriorated condition. While more costly, this comprehensive approach addresses the underlying issues effectively, ensuring the stability and longevity of the pavement.
