TIMBER FASTENERS
PROJECT ID: CEEN_CPST_013

A Capstone Project Final Report

Kip Apostol
Of Euclid Timber Frames

Department of Civil and Construction Engineering
Brigham Young University

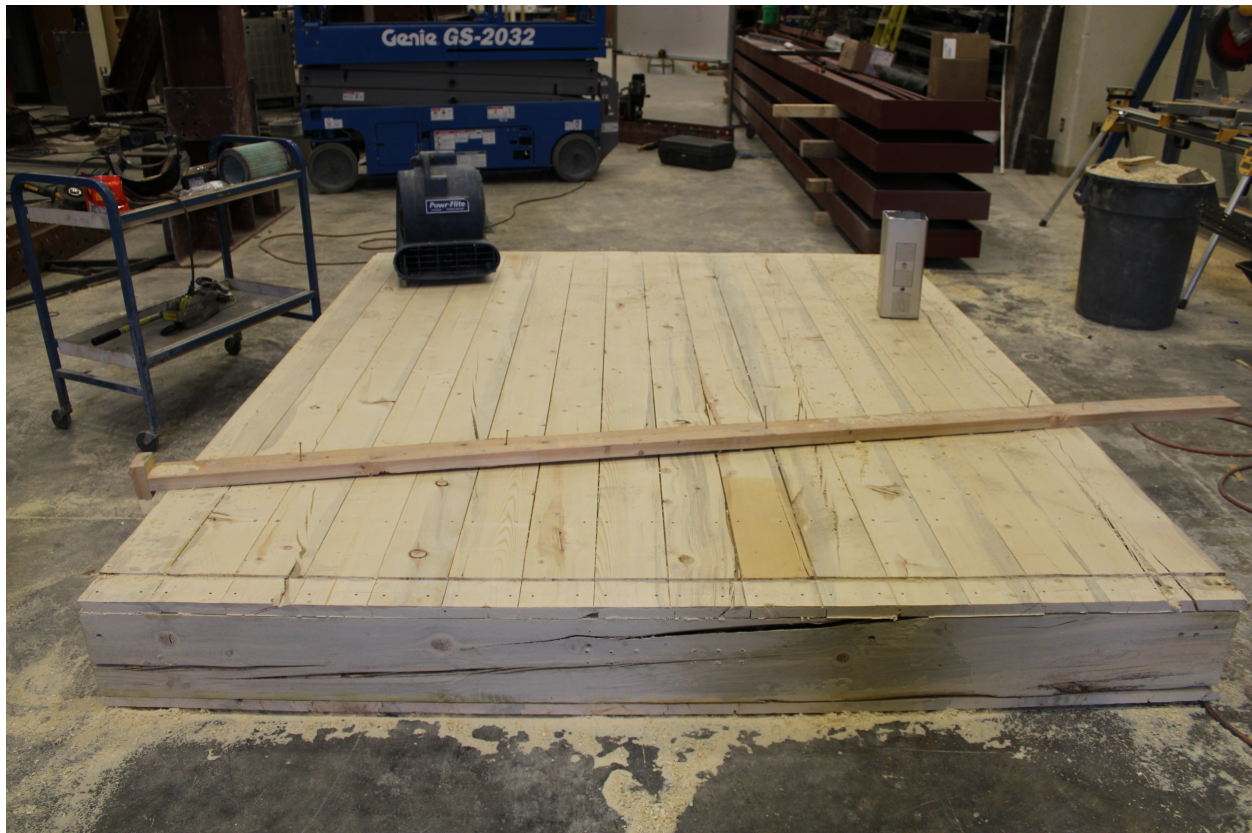
Figure 1: Wall 1 After Modifications

After receiving our first timber wall shipment from the sponsor, ADW engineering found that the original frame design needed revision. The original specimen had an overhang used in the field by Euclid Timber Frames to install the wall in the field. The overhang was normally inserted over a wooden base which added extra support and strength at the connection. Due to the constraints of ADW Engineering's original frame design and to be as economical as possible, ADW Engineering and sponsor agreed to cut off the overhang so as to adhere to the original frame design. After the first test, it was found that the shear wall failed first at the bottom, near the points of connection. It was also observed that there was little to no deformation of the actual screw connections attaching the frame to the wall. This failure led ADW engineering to believe that the connection type was suboptimal and influenced the results of our tests, warranting redesign of the testing frame. After discussion with the sponsor, the sponsor provided a new set of walls with the installation plate already inserted. ADW revised their testing frame design, adding Simpson Strong Ties (STHD8) at the bottom connection at either end of the testing apparatus to more closely represent the infield conditions of the wall. Both parties agreed to continue testing with more confidence in the data; however, the next test found that the readily available metal straps were too

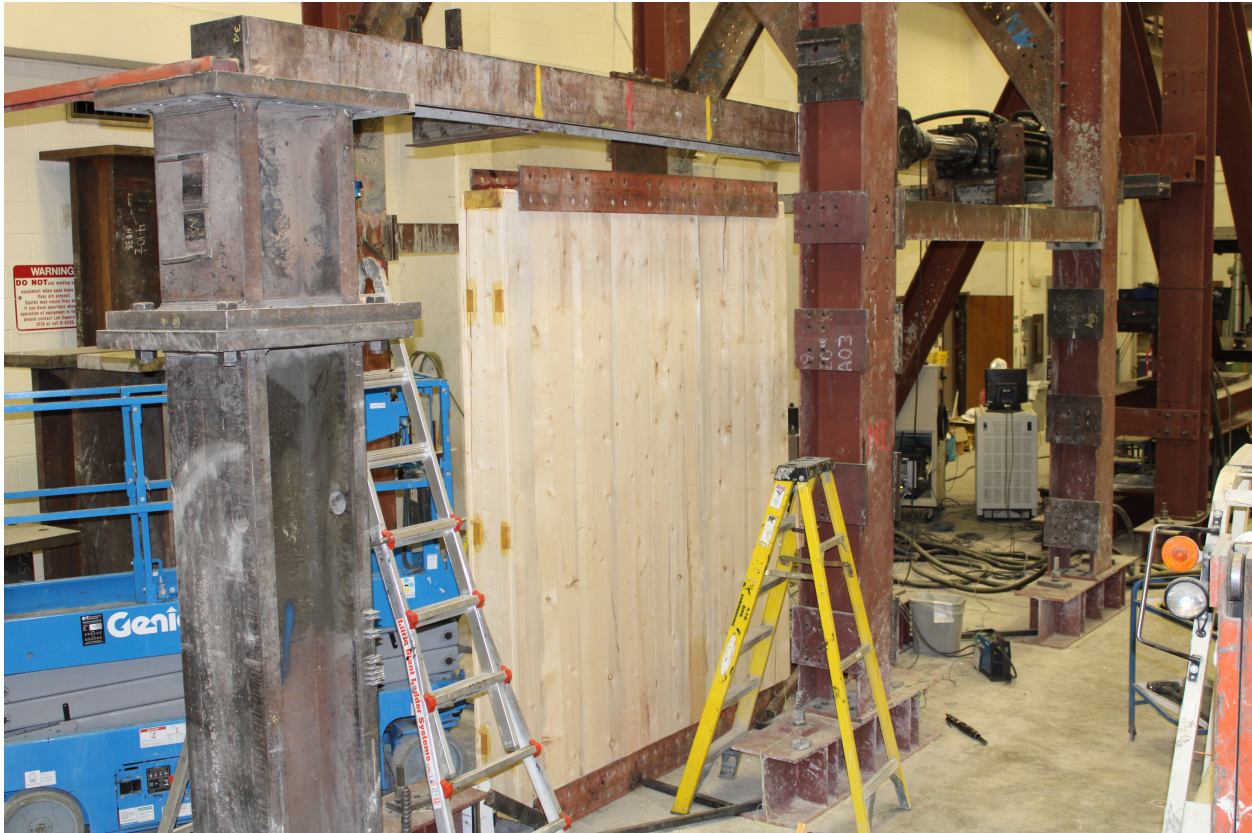
Figure 2: Preliminary Testing Frame Design

The ADW engineering team began our testing frame design by holding several meetings with the BYU structural lab team and brainstorming several possible frame designs that could apply the desired loading to our wall samples. We expected to need to apply at least 40 kips to our wall to induce failure because of literature reviews conducted by the ADW Engineering team (See Figure 1A). Ultimately the team settled on a pair of sleeves on the top and bottom of the wall to serve as the connection pieces from our wall to an already existing testing frame in the BYU structural lab. To use this testing frame design, the ADW engineering team had to make several alterations to the walls provided by the sponsor. The first two walls delivered to ADW Engineering had an overhang used in the field to better facilitate connections to a concrete base structure. After discussion with Euclid, the overhang was decided to be non-essential and was cut off. ADW Engineering also routed $\frac{1}{4}$ " off either outside face of the CLT wall with Euclid's consent in order to fit the BYU structures lab's readily available sleeves. Both of these changes were adopted so as to be economical and expedite the testing process, and allow for installation of the walls into the existing steel members. Without these changes, new steel members would have had to be manufactured at significant expense to ADW Engineering and slowing down the testing process. This preliminary design can be seen in Figure 2 below.

After selecting our initial design, ADW Engineering performed several calculations to ensure the frame was strong enough to restrain the wall and resist any load applied to the wall, including calculations to select an appropriate size pin to connect our actuator to the top sleeve. After our initial series of calculations, the testing frame members were accepted, and the frame was built.

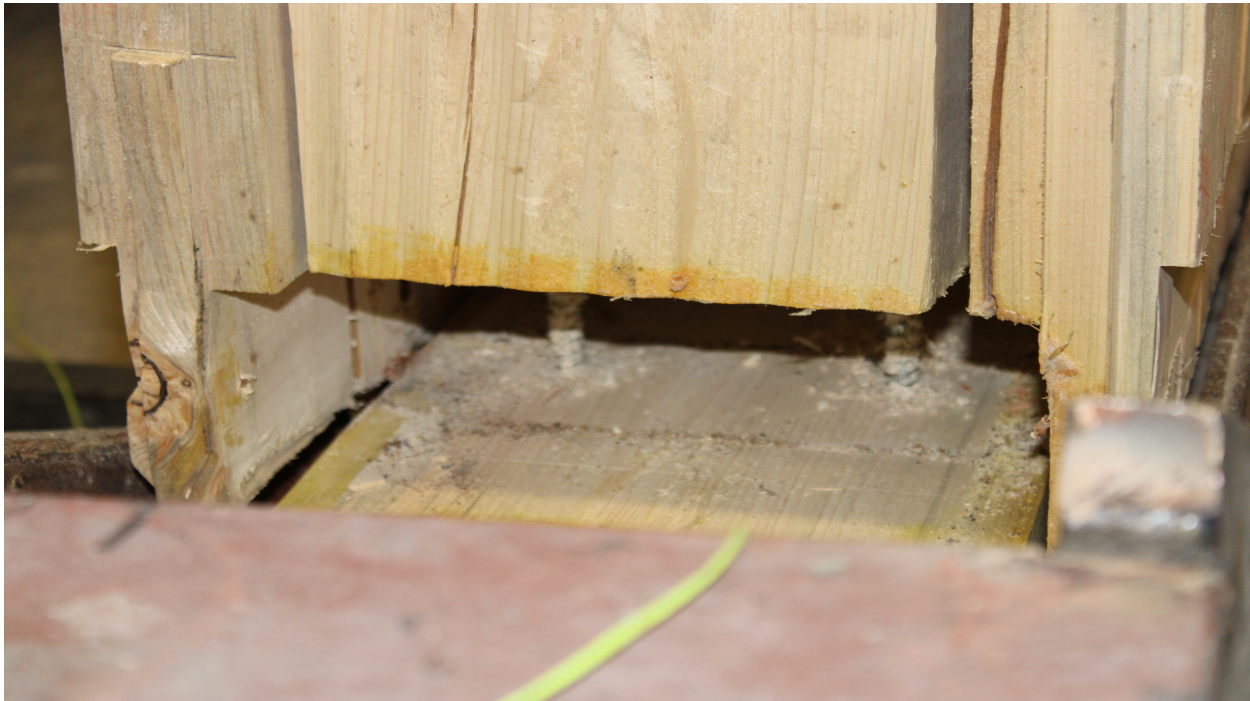
Figure 3: First Wall Failure Mode

After the initial wall test, the ADW Engineering team recorded the data and photographed the failure plane as seen in Figure 3 below.

The first CLT Timber wall failed at the bottom plate. From our initial inspection of the failure, the ADW Engineering team concluded that the given plane of failure was at the bottom plate and that the results may have been skewed by the large screw connectors embedded in the material which did not accurately represent in field conditions. This was alluded to in both Figures 3 and 2A as the screws themselves exhibited little to no deformation despite being directly adjacent to the failure plane. The maximum strength measured from this test was approximately 20 kips (See Figure 5). The displacement of the wall at failure was approximately 4.5 in.

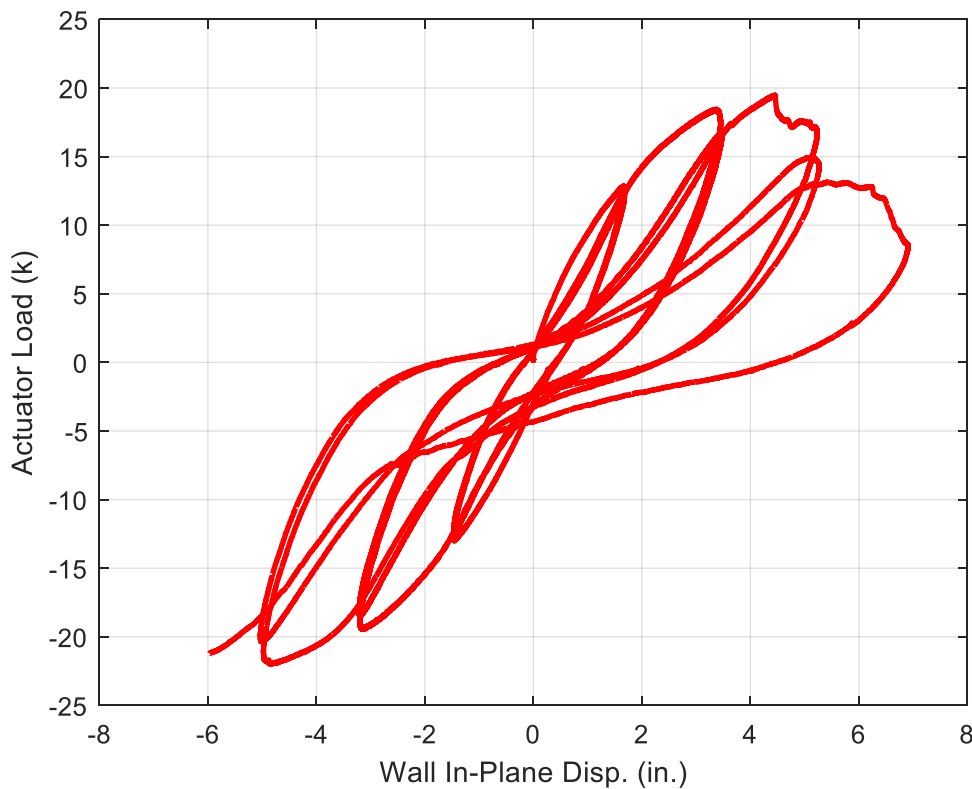
Figure 5: Wall 1 Load vs. Displacement

This measurement is likely significantly higher than the actual strength of the wall due to the added stiffening of the large screw connectors. As such, the wall was redesigned to correct this issue. The ADW Engineering team identified several adaptations to account for the overhang and other flaws in the current iteration of the wall design, and so the testing frame was altered to reflect these changes.

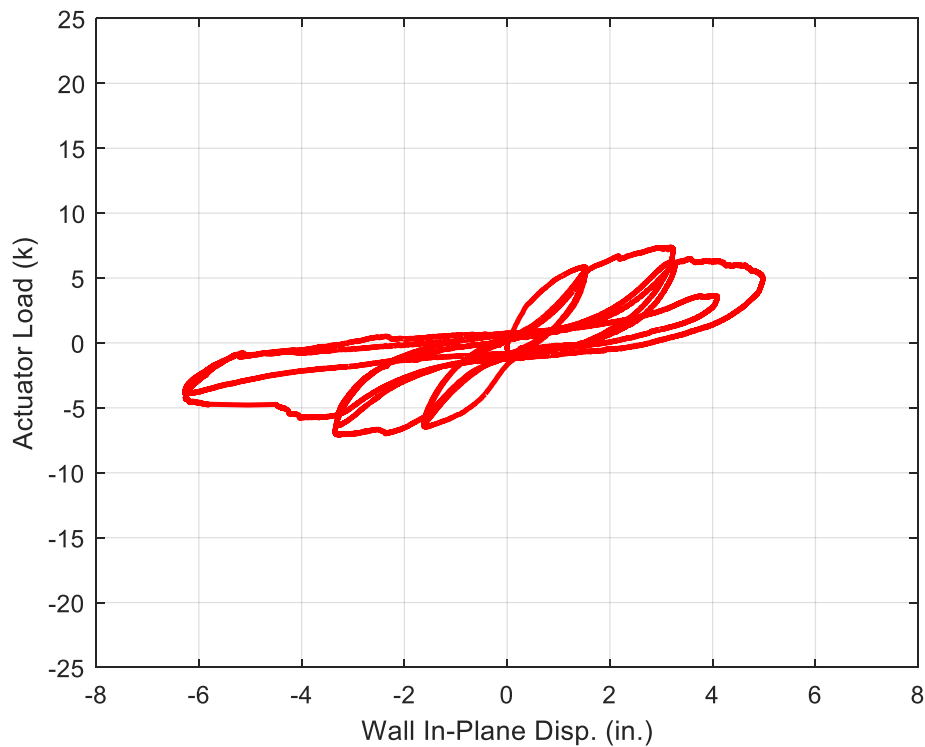
Figure 6: Wall 2 Load vs. Displacement

For the second wall, the wooden base traditionally used by the sponsor in practice was placed in the overhang to better reflect the infield conditions of the CLT frame walls and to eliminate any issues caused by said overhang. There were also several alterations made to the testing frame. ADW Engineering

changed the design to only use lag screws in each vertical member, mirroring common practice for Euclid Timber Frames in the field. ADW also redesigned their connectors, using 61 4" lag bolts in the bottom member for similar reasons. Most importantly, the team screwed into the wall laterally instead of vertically, as done in wall 1. Although some minor alterations were made to the testing frame, the testing procedure remained the same (see Figure 4A in Appendix). After running the test, the ADW Engineering team noticed a similar failure plane along the bottom of the wall. The maximum strength measured for wall number two was approximately 8 kips. (See Figure 6) The displacement of the wall at failure was about 3 in. The measured strength was much lower than that of wall one, confirming to ADW Engineering that the first wall's strength had been affected by the first wall frame design. During the testing phase, the wall exhibited significant rocking, which would affect the results of the test. Since the wall failed prematurely, ADW Engineering returned to the design process to improve the frame-wall connection for future tests.

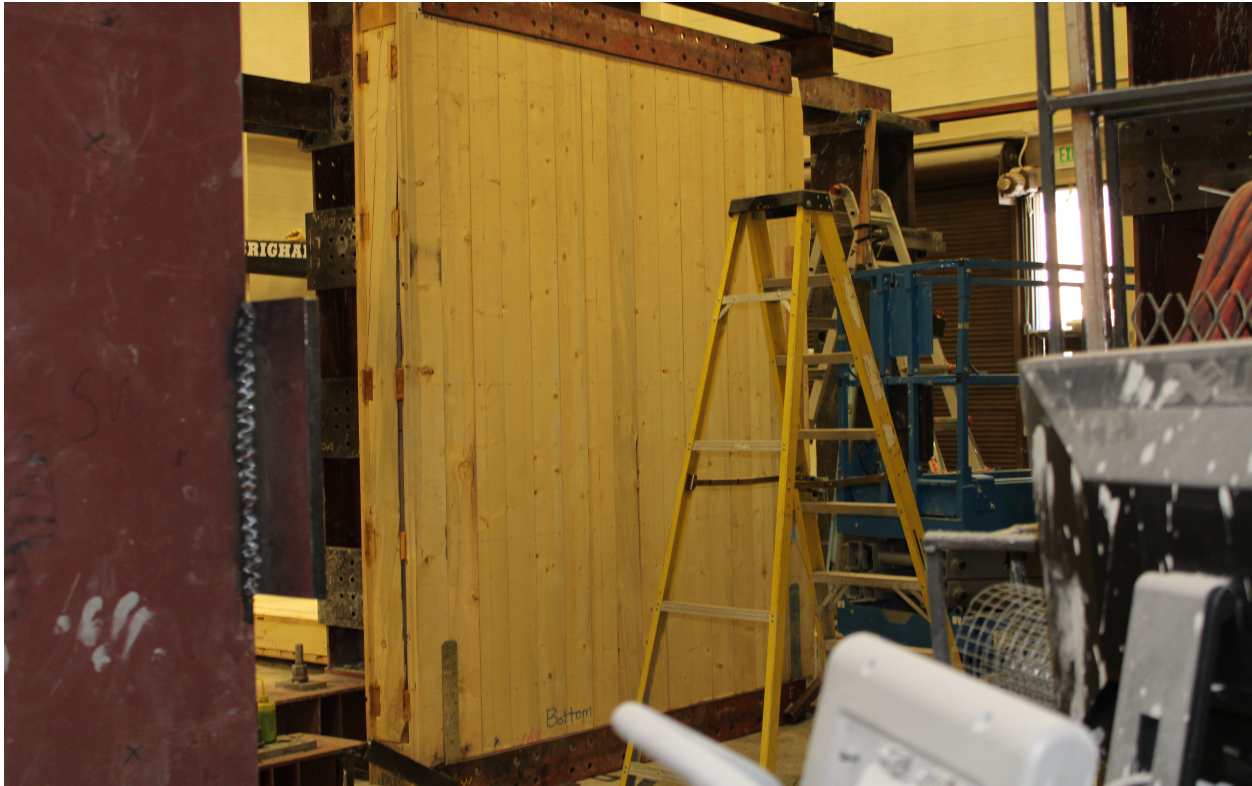
Figure 10: Third Wall Frame Alteration

The third CLT timber wall testing frame was redesigned including (2) STHD8 steel straps on either side of the bottom of the testing frame to add extra support rocking. The redesigned testing apparatus can be seen in Figure 10 below.

The fourth wall test was performed using the same frame design as seen in Figure 10. The thicker steel straps can be seen below in Figure 14. The same testing procedure was followed with the fourth test and the wall was loaded till failure. The last shear wall also failed at the metal straps. The maximum strength of the wall was measured to be about 14 kips. (See Figure 15). The maximum displacement at failure was approximately 4 inches. Since the wall failed first at the metal strap connections, the ADW Engineering team concluded that the actual strength of the wall is higher than that measured.

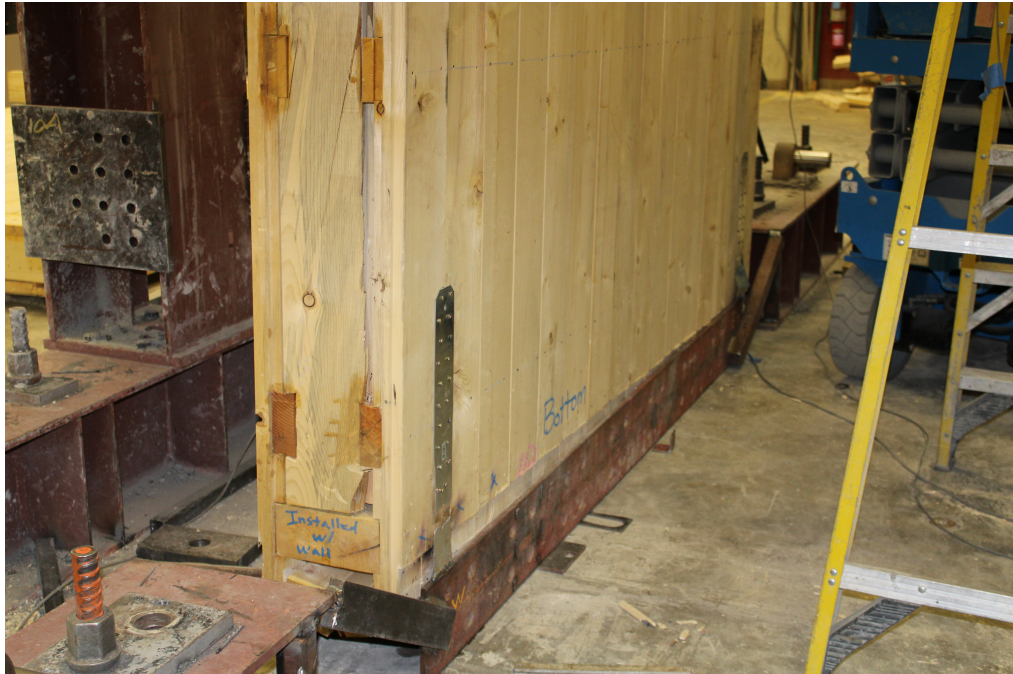
Figure 11: Third Wall Primary Failure Mode

The testing procedure was again held constant during the third wall test. This test was much shorter than the previous two wall tests, and the wall failed first at the straps, which broke clean through (See Figure 12). This would affect our results by lowering the maximum measured strength of the wall. The approximate measured strength was 17 kips (See Figure 11). The displacement of the wall at failure was approximately 4.8 in. After discussion, the ADW Engineering team and Euclid engineering concluded that thicker metal straps may resolve this issue. The sponsor provided a second set of (STHD14) metal straps which were used for our final shear wall test.

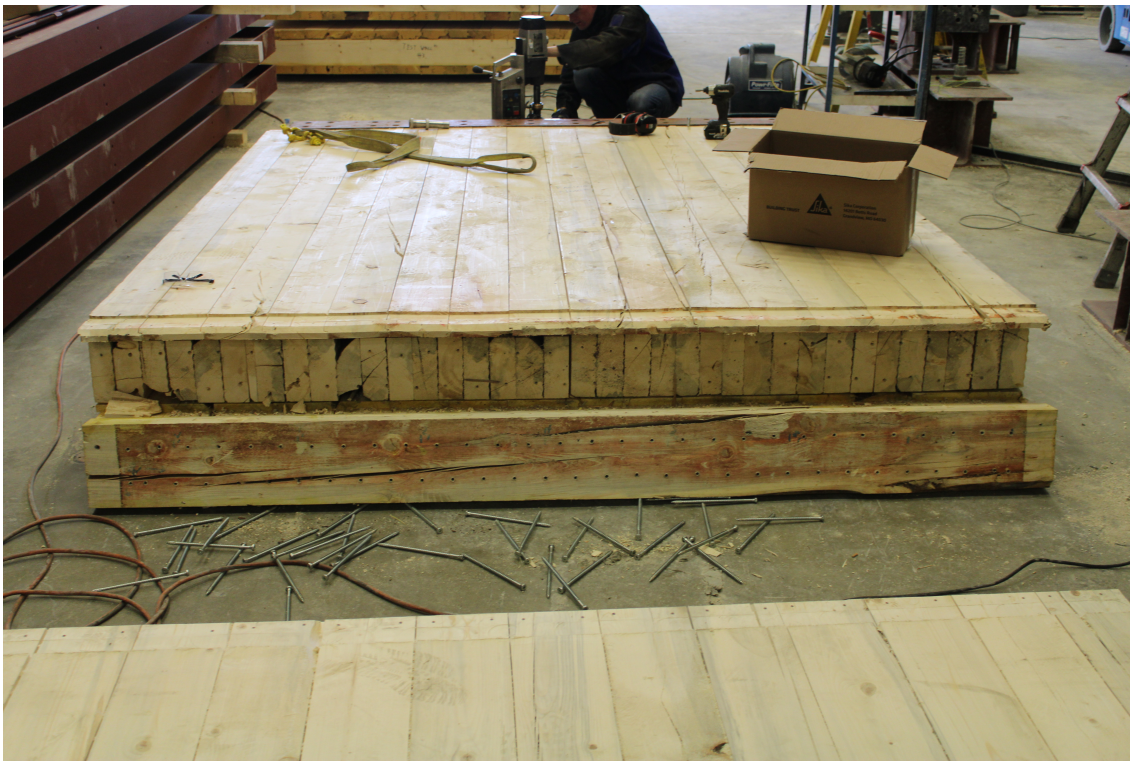
Figure 2A: Connection Screws After First Wall Failure and Disassembly

The connection point of the testing frame is the biggest limiting factor for our testing apparatus. As mentioned earlier in the Introduction section, the connection between the wall and the testing had direct impacts on our tests. In the first test, the large screws connecting the testing frame to the wall added strength at the base and skewed our results larger as proven by the lower strength results in subsequent tests. This phenomenon is also highlighted in Figure 2A below showing that the screws pulled out of wall one after failure experienced little to no deformation, suggesting that the actual connector was not the direct cause of failure. To reduce any possible influence the connector had on lab test data, smaller screws were used in subsequent tests as seen in Figure 3A below.
