**CURRENT CREEK DAM TOE DRAIN REHABILITATION**  
**PROJECT ID: CEEN\_CPST\_010**

**A Capstone Project Final Report**

**Troy Ovard**  
**Central Utah Water Conservancy District**

**Department of Civil and Construction Engineering**  
**Brigham Young University**

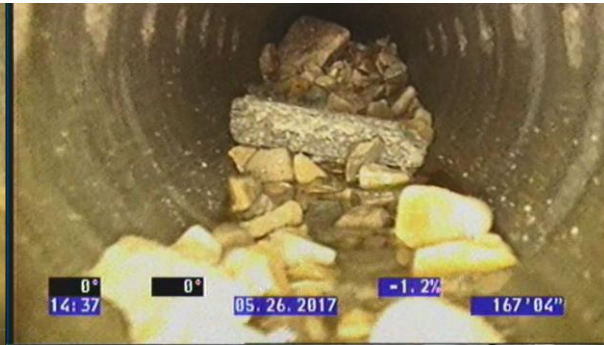
*Figure 2: Blocked portion of pipe at 170'*

A video inspection of the pipe taken in 2017 shows problems with the toe drain itself. There are several offset pipe joints in the pipe. After the jetter cleaned the pipe, water could be seen draining through those offset joints indicating the pipe might not be able to carry flow without it draining out. Further, there is significant pooling from 60 feet from the manhole to 105 feet (see Figure 6). This is a large dip in the pipe which could further prevent drainage. Then, at 170 feet there is a huge blockage shown in Figure 5 & Figure 7.

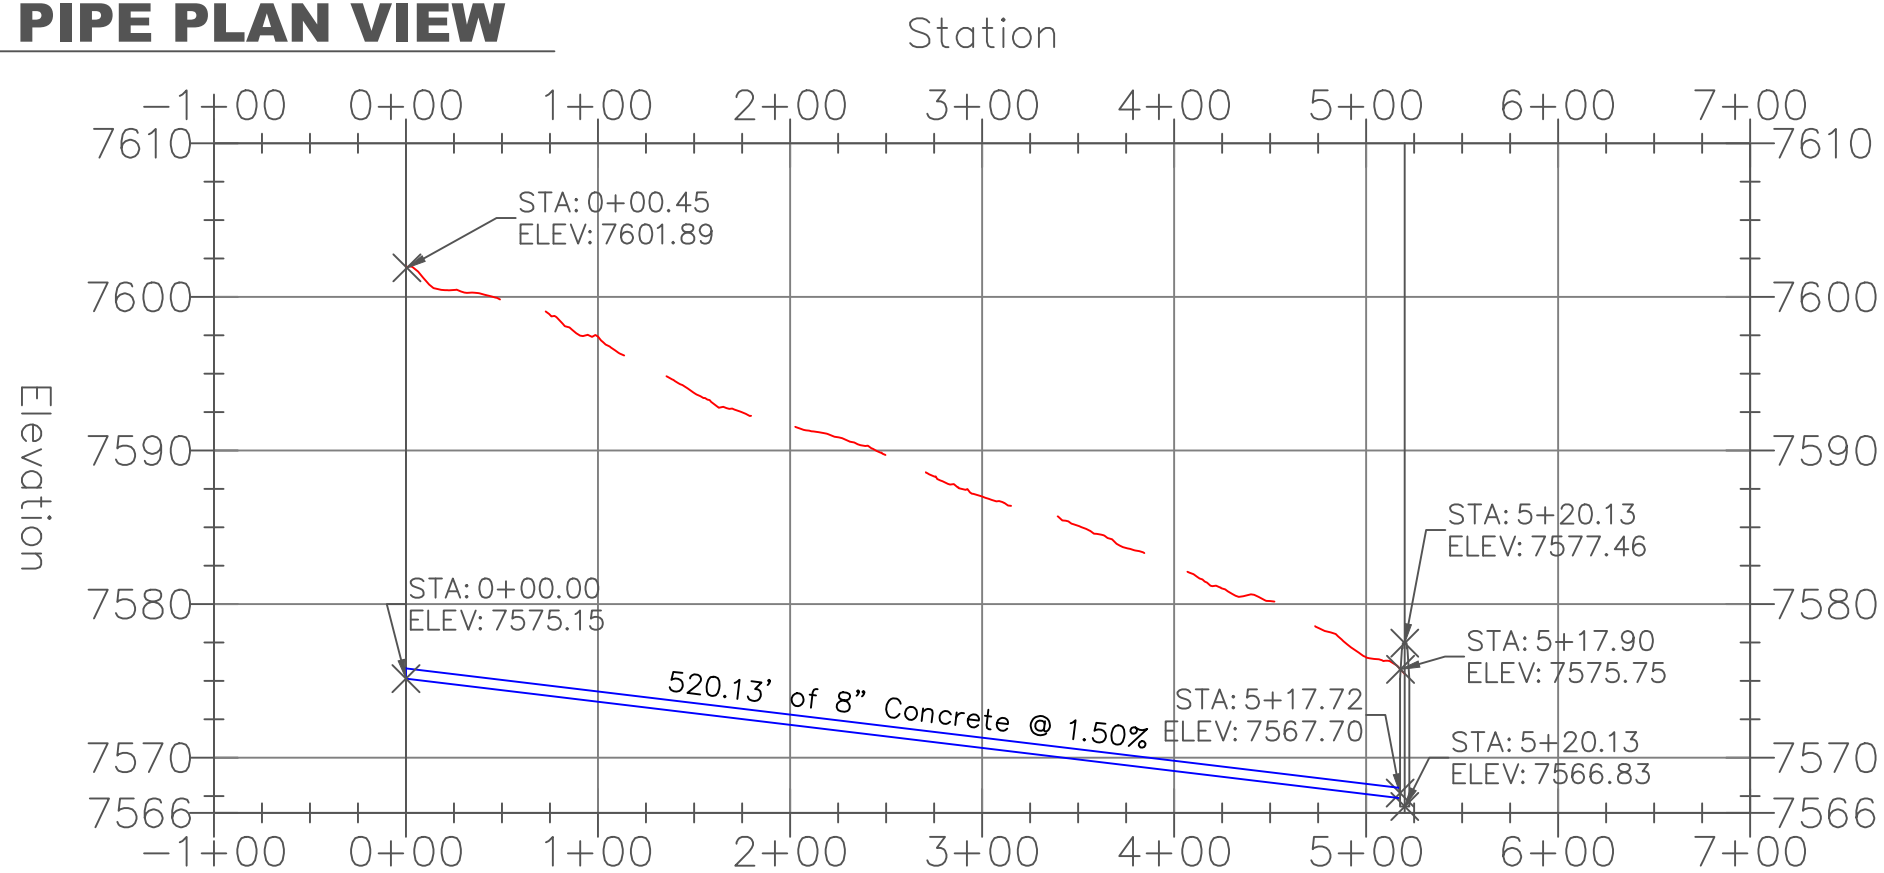
**EXISTING PIPE PROFILE**

NOTES:  
PROPOSED PIPE LOCATION  
DETERMINED FROM ASSUMED  
SLOPE, THE DOWNSTREAM  
MANHOLE LOCATION, AND  
ORIGINAL CONSTRUCTION PLANS.  
ACTUAL LOCATION UNKNOWN.

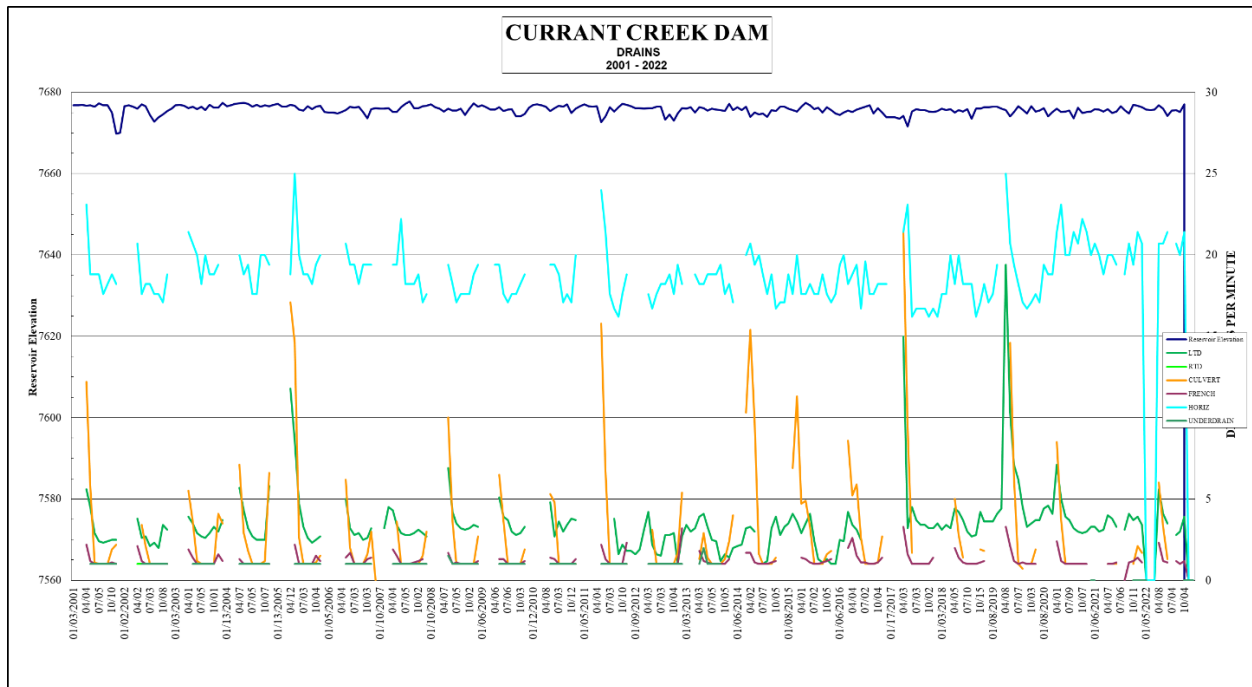
Figure 2: Measured Flow Rate in Drains (Taken from CUWCD's data)

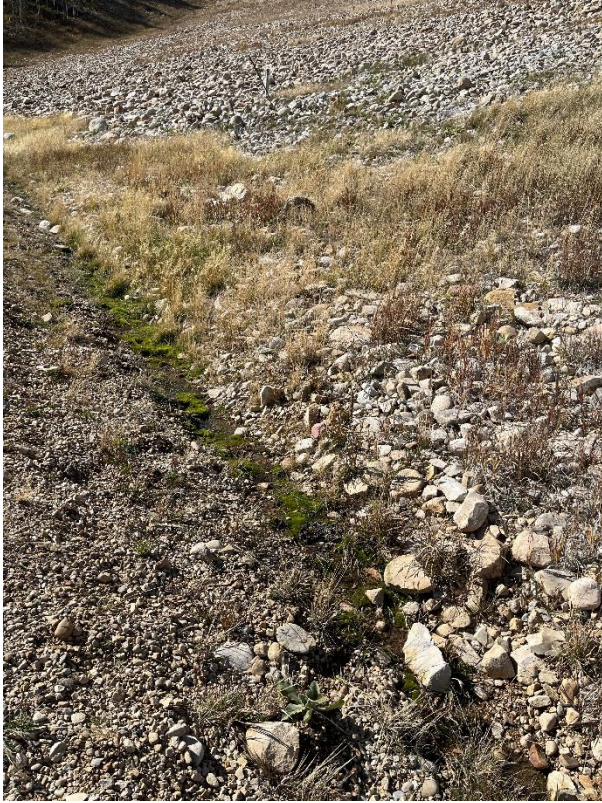
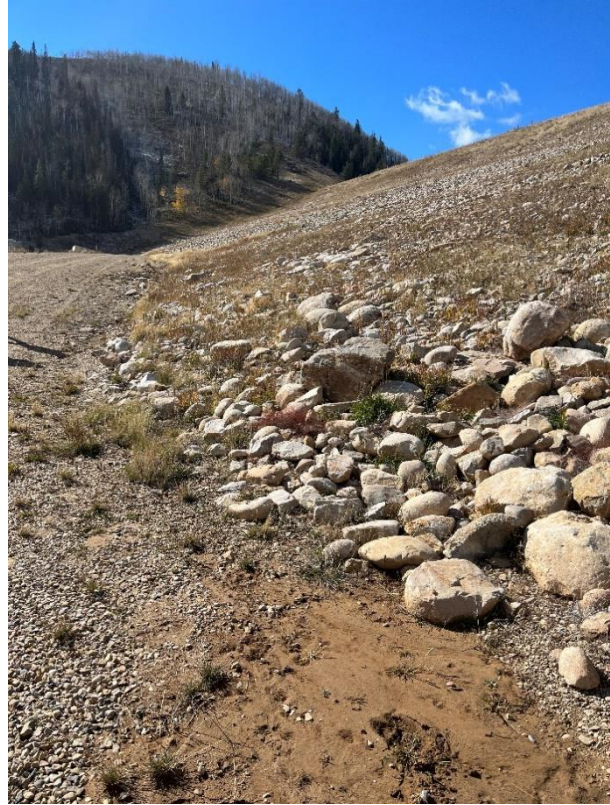
Further indication of a problem with drainage is that of plant and moss growth on the right side of the dam face. See Figure 3 and Figure 4. This further indicates there is less drainage than on the left side of the dam.

**Figure 3: Significant growth on right side of dam face**

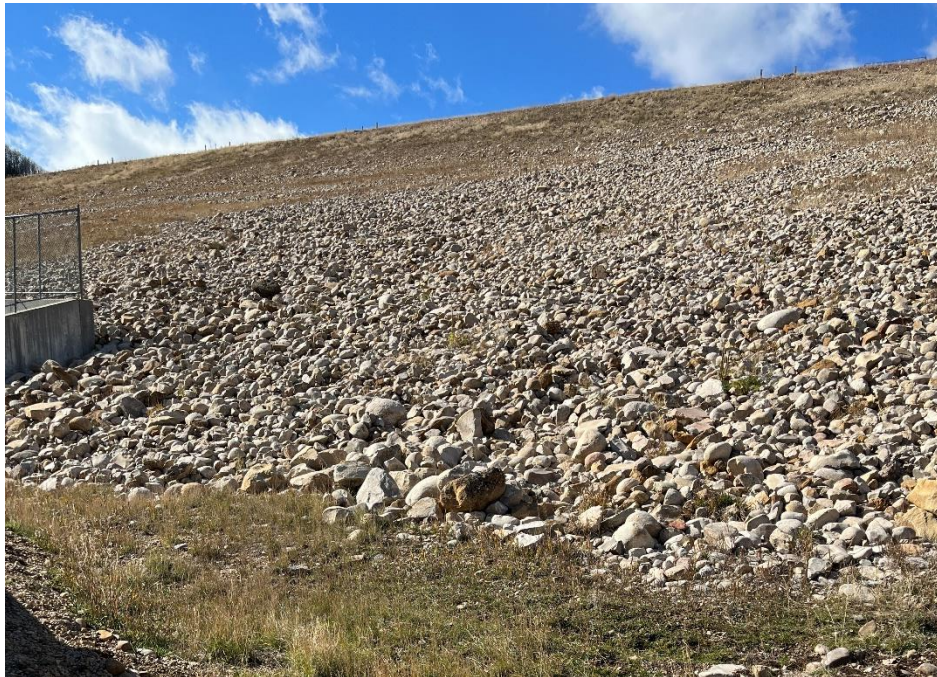
**Figure 4: Little plant growth on the left face of the dam**

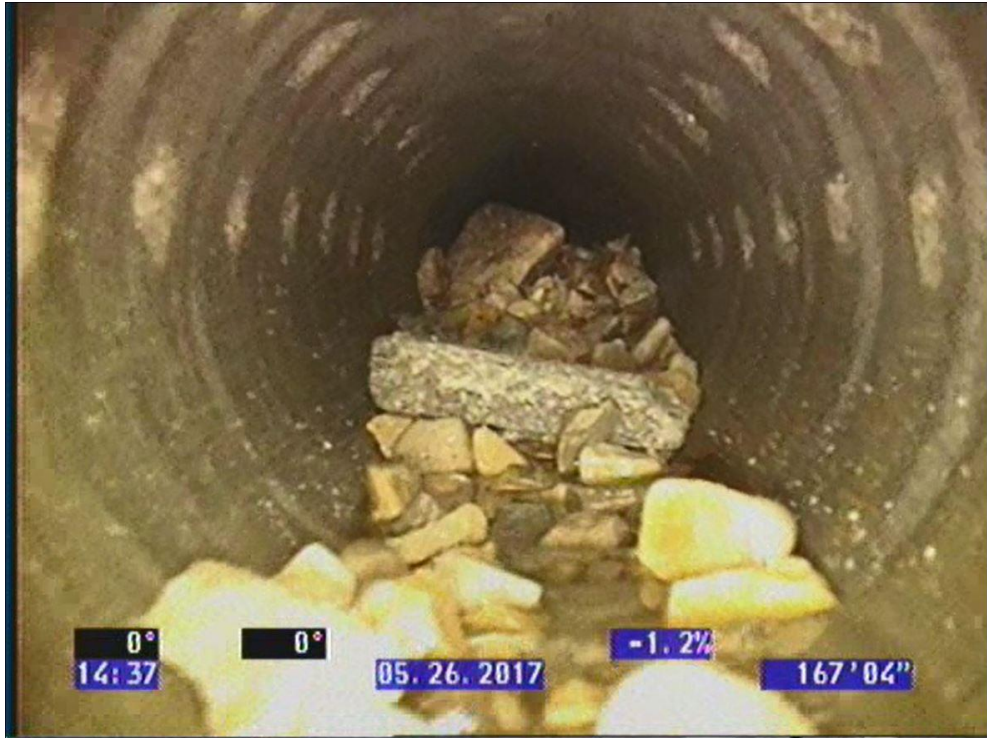
Figure 5: Large Blockage around 170 feet

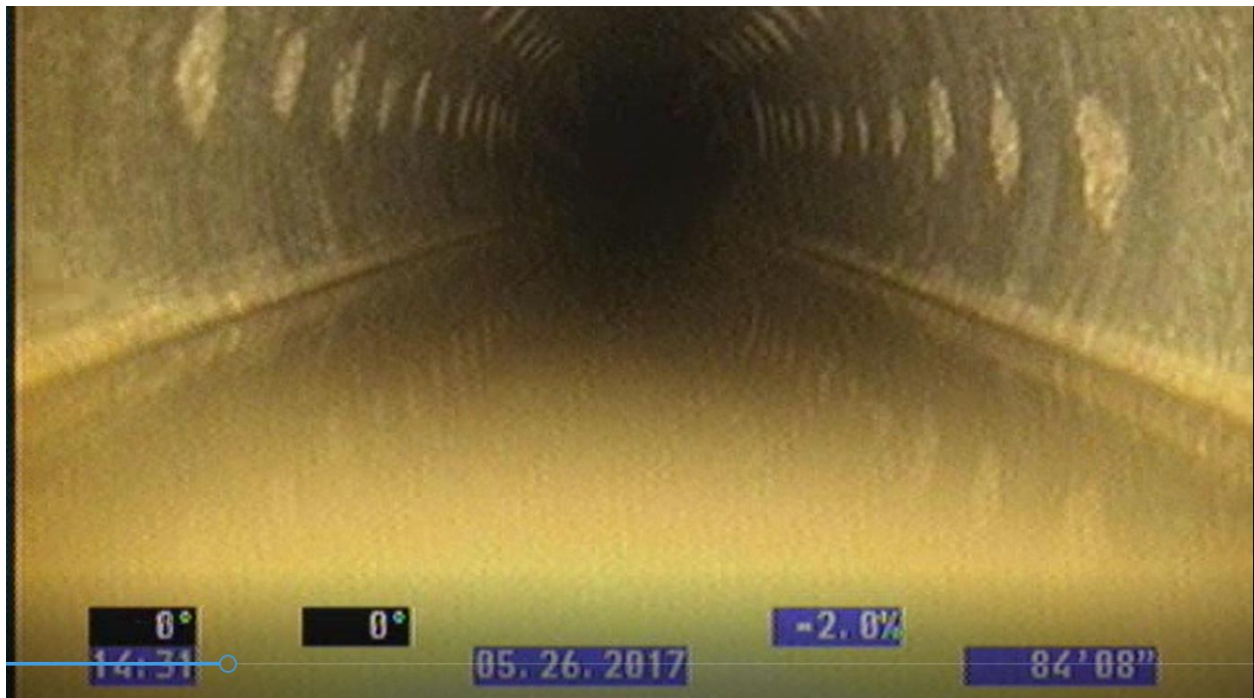
Figure 6: Standing water in large dip around 80 feet

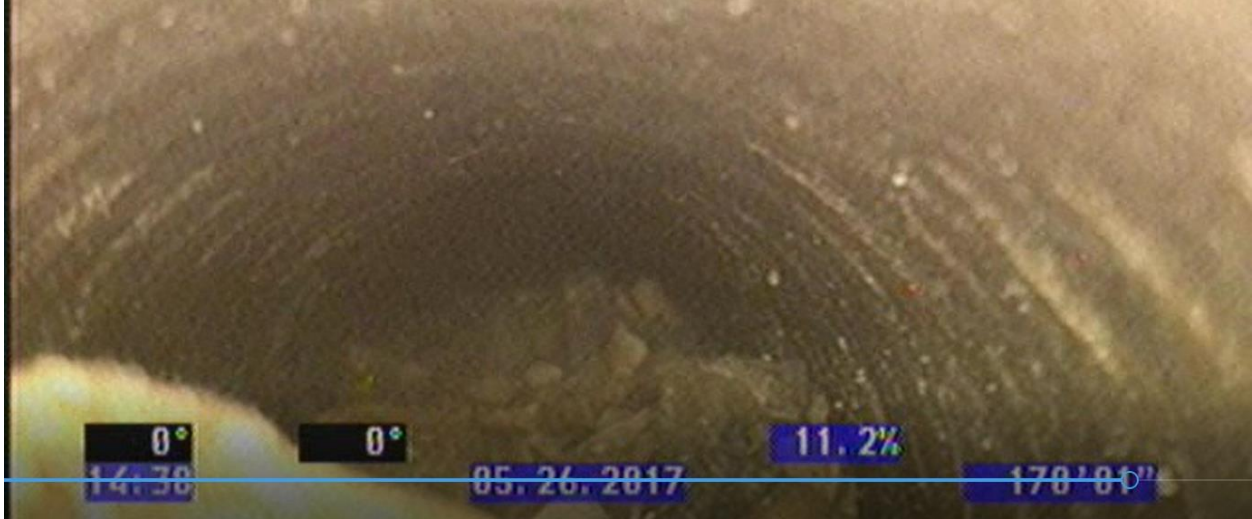
Figure 7: Zoomed in image showing further blockage behind large blockage at 170 feet

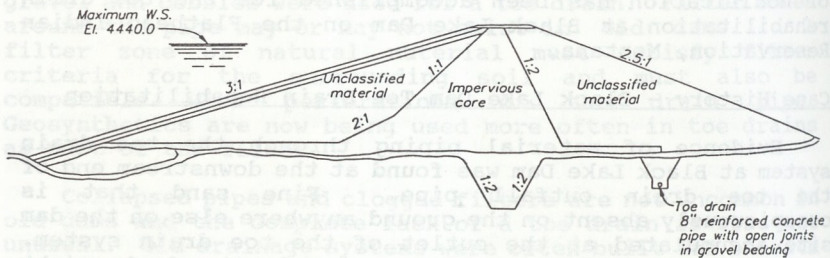
FIGURE 2. - Typical Cross Section of Black Lake Dam

The drain is aligned parallel to dam centerline and located about halfway between the dam's downstream toe and the seepage cutoff trench, about 20 feet below original ground surface (see figure 2). When the dam was originally constructed, the drain was able to be placed in its current location because it was constructed prior to placement of the embankment fill. It effectively controls the phreatic line through the embankment, keeping water away from the dam's downstream face. It is located adjacent to an impervious blanket which directs flow passing by the seepage cutoff to the drain. Therefore, the location of the dam is ideally suited to drain any water that would reach the downstream portion of the dam and the foundation immediately below the dam; however, the drain pipe openings are too wide and have allowed soil to enter the pipe. Since the drain was a conduit which carried piped embankment and foundation materials, it was a threat to the safety of the dam and required rehabilitation. Because the drain was located so far under the dam, the rehabilitation was performed in place.

The two basic functions of the Black Lake Dam toe drain rehabilitation were to stop piping and to maintain drainage. Piping was stopped by screening of the piped material through flexible perforated pipes inserted into the original drain. Adequate drainage was maintained through the perforations of the insert drain pipes.

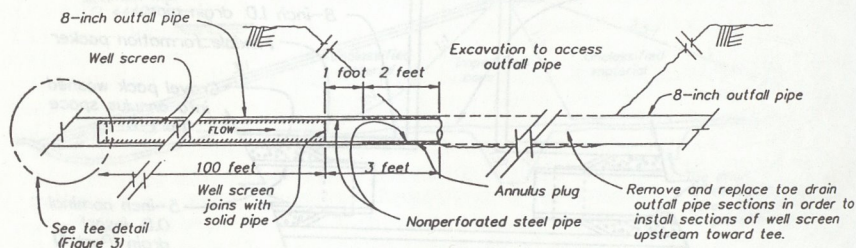
Figure 4. - Outfall Pipe Rehabilitation

Even though the piping problem is remedied, it is recognized that placement of gravel and pipes within the original toe drain reduces the drainage capacity of the system. This may result in increased foundation pore pressures and an elevated phreatic line within the dam.

Part 2 of the toe drain rehabilitation consisted of an additional means of eliminating piping of material through the drain system. A continuously slotted, steel well screen was inserted into the outfall pipe beneath the dam near the tee of the drain system (see figure 4). Plugs were installed so that flow in the toe drain system is forced to go through the well screen before traveling down the outfall pipe.

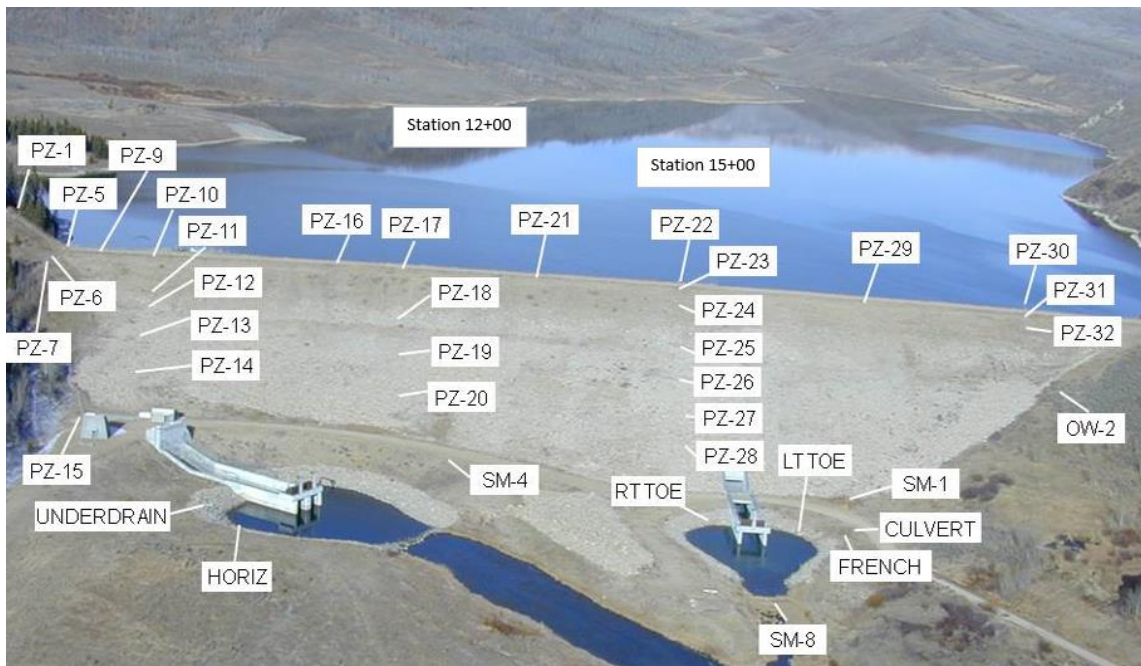
With the right toe drain (RT TOE) not functioning, it would be expected that the area around stations 12+00 to 15+00 would be most at risk of increasing water levels. This is evident by the vegetation growing around those regions of the dam, particularly at toe of the dam. Below is an image of the dam (provided by CUWCD) with the piezometers labeled. This analysis will look at the piezometer data for those at the aforementioned stations. This covers PZ-18 to PZ-28.

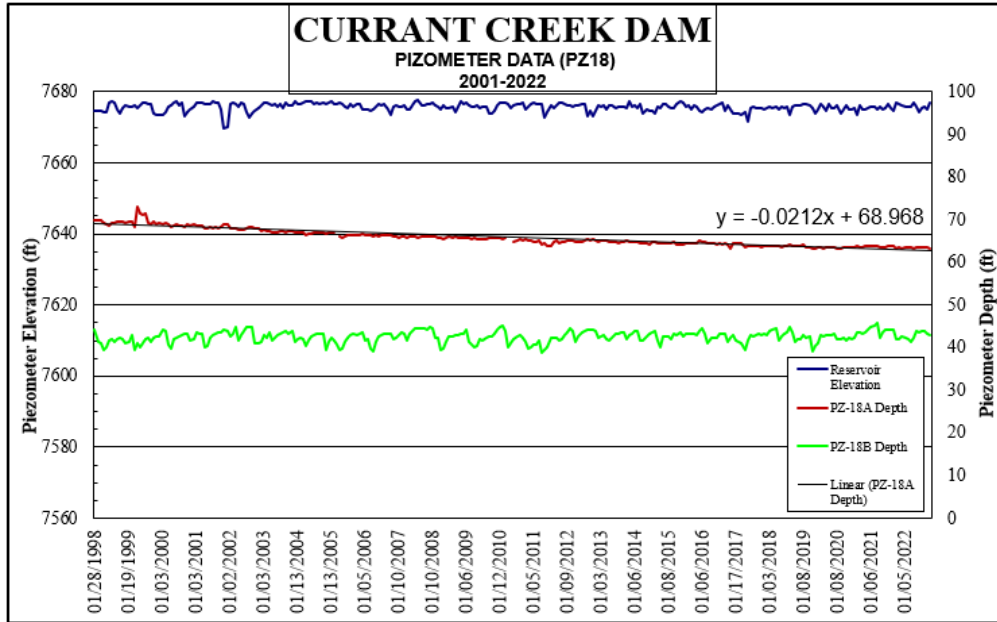
### PZ-18

Oddity: PZ-18B, the upper portion, is stable while depth of PZ-18A, the foundation zone, is trending downward.

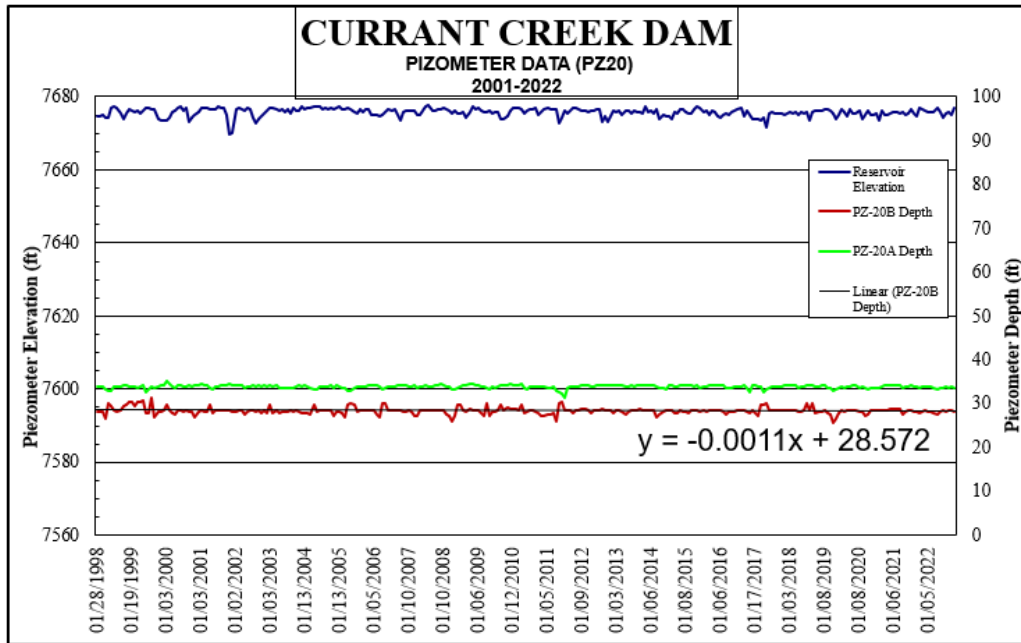
### PZ-20

**PZ20**  
PZ20 is virtually horizontal. projections of lower depths extend to thousands of years

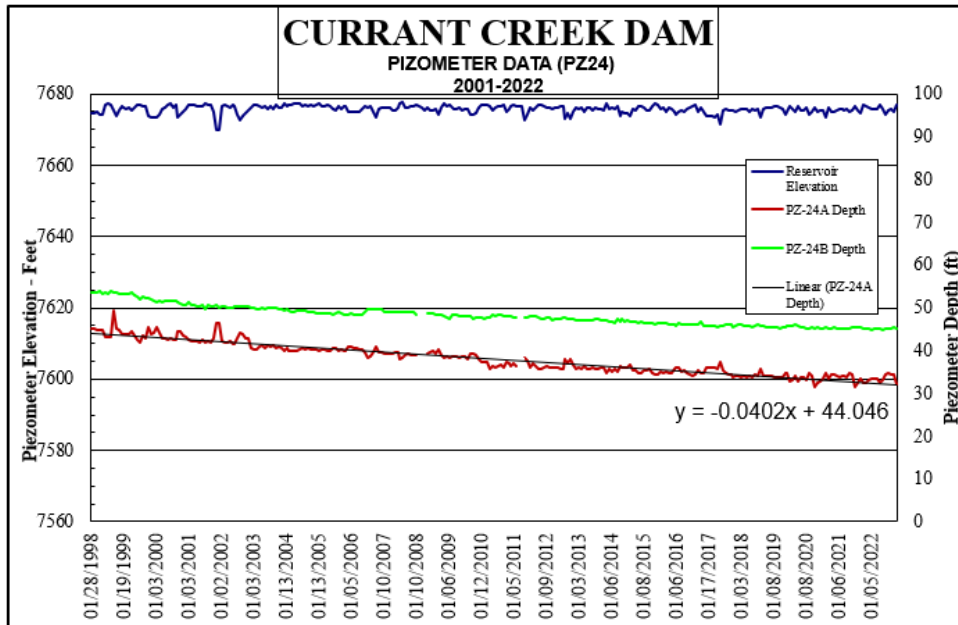
### PZ-24

According to this analysis, PZ-24 would reach a depth of 0 ft first.

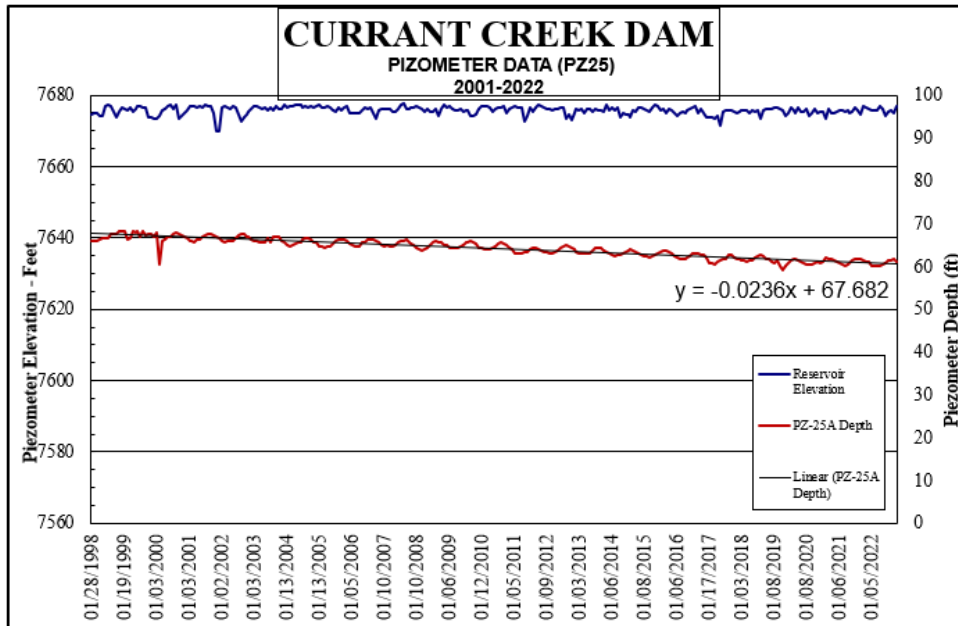
### PZ-25

Data from PZ-25B has not been recorded since 2007.

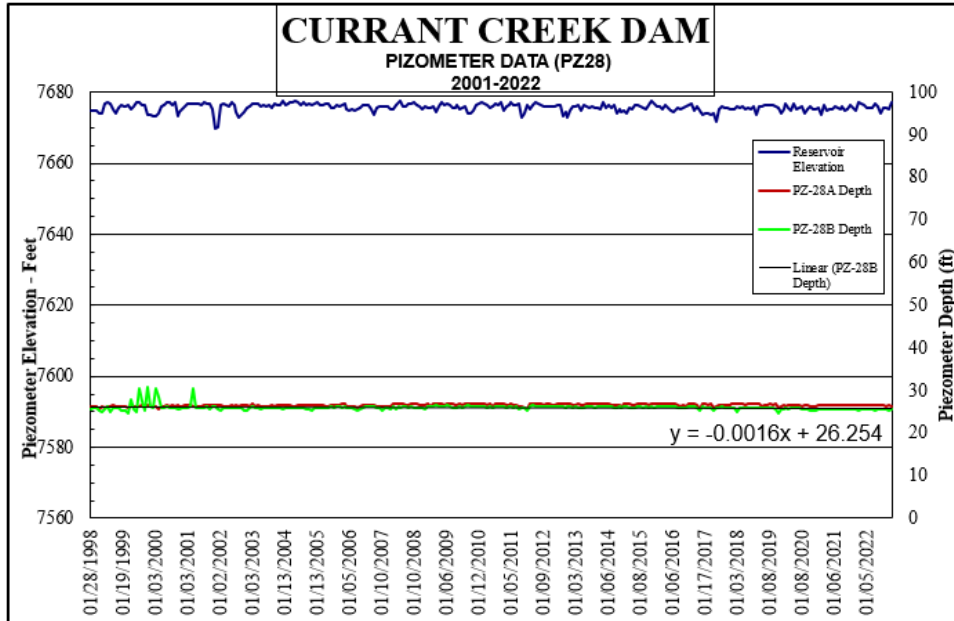
# PZ-28

PZ28 is virtually horizontal.

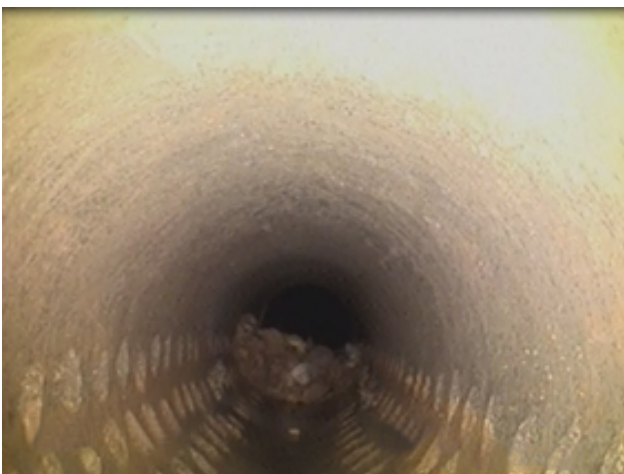
Photo 3 – View of a gravel pile obstructing access in a toe drain.

Photo 4 – View of the location of the gravel pile in Photo 3 following the cleaning. Notice there is no more gravel or sediment.

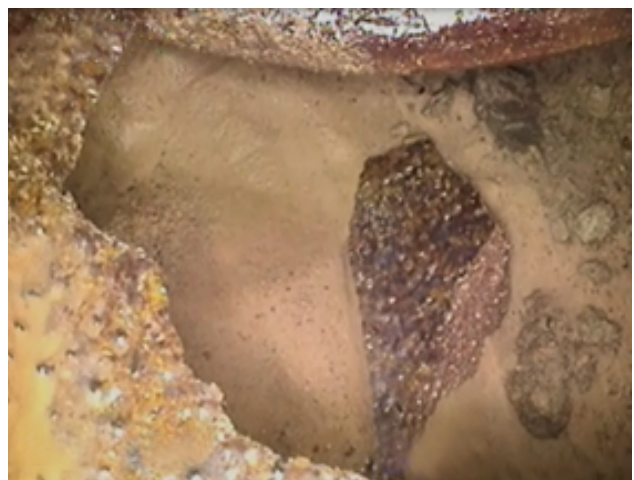
Photo 7 – A jetter quickly eroded out material in this area and developed a much larger hole.

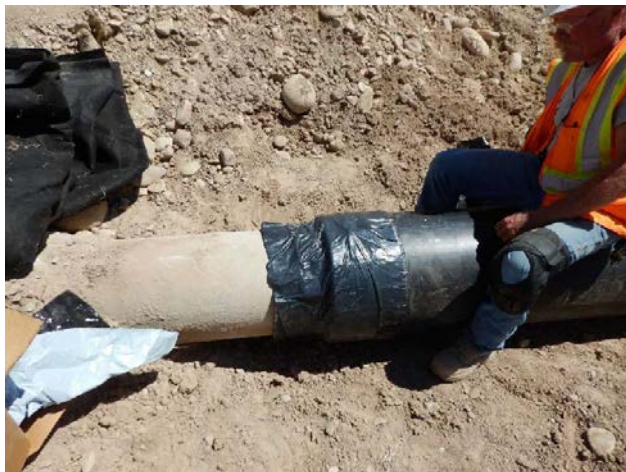
**Transitions** – Access issues occasionally occur at transitions between pipe sizes. When these transitions are concentric (i.e. when the centerlines of both pipes are the same), an insurmountable barrier is created, permanently preventing access with inspection and maintenance equipment (Photo 24 - Photo 26). While there are many ways around this, eccentric transitions (i.e. when the inverts of both pipes are aligned) are far more accommodating and are therefore recommended (Photo 27). Where needed, grout can be used to fill the gaps created by these transitions (Photo 27).

Photo 24 – A broken portion of 10-inch-diameter concrete toe drain pipe being replaced with concentrically-placed 12-inch-diameter HDPE.

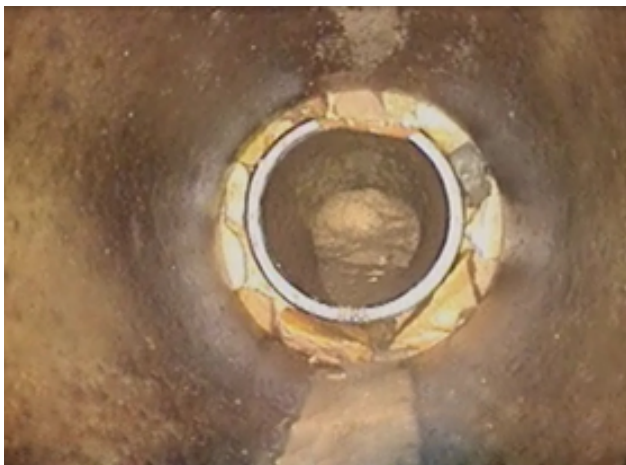
Photo 26 – Concentric pipe transitions can create an access barrier.

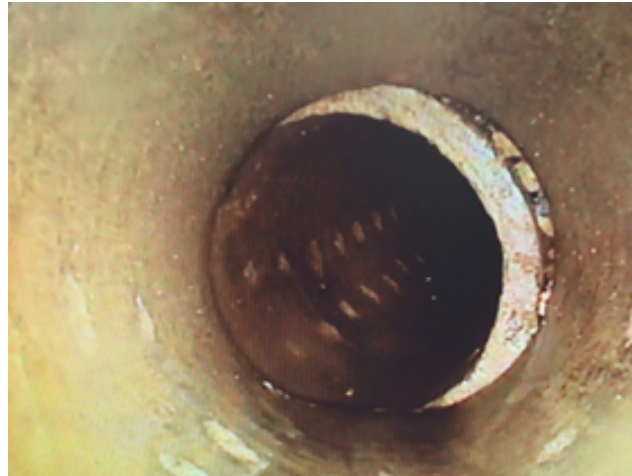
**Offsets** – As previously mentioned, offset joints between pipe sections present another obstacle for inspections and maintenance. These offsets decrease the available pipe area for inspection equipment to access the pipe, in some cases permanently limiting access of the drain (Photo 28 and Photo 29). This is primarily a problem with open-jointed or loosely-connected bell-and-spigot connections, which can easily become dislodged during construction or due to settlement. If these connections are to be used, then consideration should be given to ensure that conduit joints are well connected, and that the pipe diameter is large enough (a minimum of 10 inches) to allow for inspection and maintenance access even if small offsets occur at the joints.

Photo 29 – Offset in a concrete pipe which prevented further inspection of the toe drain.

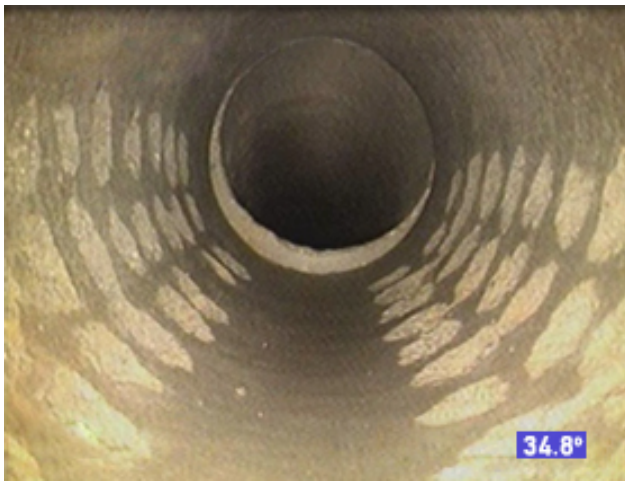
Ultimately, the maximum slope depends on the distance from the access point and the friction provided by the pipe, which is a function of its material and the amount of water, sediment, and biofilm present. In dry concrete pipe, for example, slopes as high as 34° have been ascendable (Photo 30), whereas wet corrugated HDPE or CMP is difficult to navigate at even minimal (0.3°) slopes (Photo 31).

Photo 30 – View of inspection equipment accessing a steep (34°) abutment drain. Access was ultimately limited by a significant change in slope, and subsequent offset, at the top of the incline.

**Slope Changes** – As with pipe sizing, an abrupt change in slope between pipe sections can also present an obstacle for inspection or cleaning equipment (Photo 30). Not only do abrupt slope changes present gaps and offsets, but depending on the pipe diameter, they can also high- or low-center an ROV. It is therefore recommended that slope changes (as with pipe bends discussed below) be limited to 22.5° at any given location.

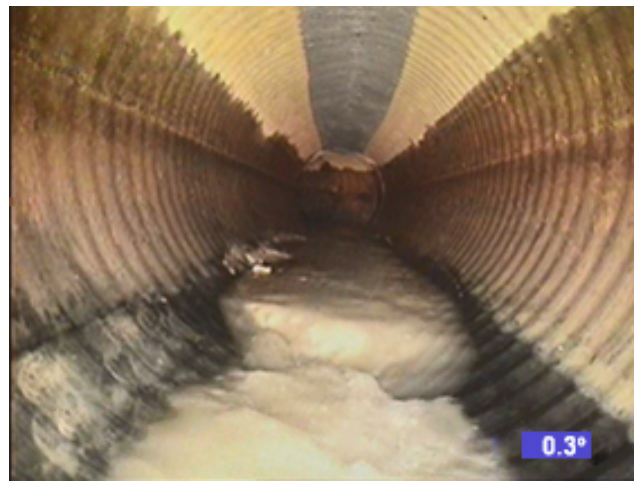
From an inspection and maintenance perspective, plastic pipes offer very little traction to ROVs, especially with travel up steeper slopes. Even drains with mild slopes (0.5%) can be too slick for inspection equipment if seepage flow is present (Photo 31). If plastic pipe is to be used, then an additional access point should be provided at the upstream end of the drain to allow for downstream travel.

Photo 31 – View of a corrugated double wall HDPE pipe with minimal slope (0.3°), which was so slick that access with inspection equipment was severely limited.

If there is a possibility that access will be difficult due to the slope or material of the pipe being specified, then access points at the upstream ends should be included in the design, since downhill access is far easier than uphill access. This provides the additional advantage of allowing cleaning operations to be conducted from an outfall, while a camera-crawler monitors the cleaning from the upstream direction (Photo 4).

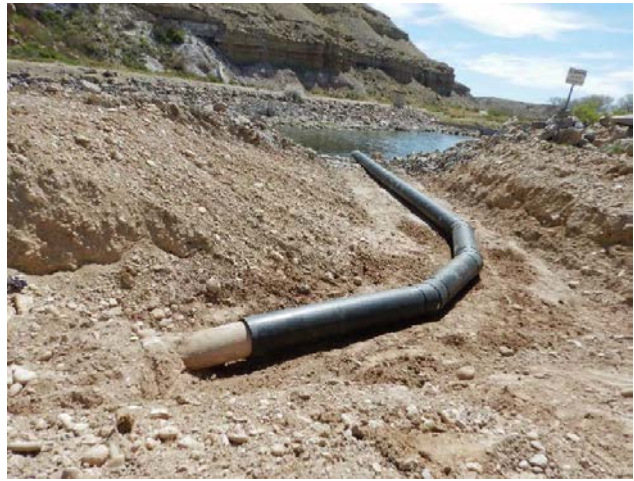
Photo 35 – New alignment of the pipe shown in Photo 34, allowing inspection access.

Turns are unavoidable in most toe drain systems, but layouts can be designed with gradual turns so that inspection and cleaning equipment can navigate them more easily and the amount of friction on the cable and hose can be reduced (Photo 34 and Photo 35) [17]. It is recommended that bends no greater than 22.5° be used in toe drain systems, and that a 5-foot-long straight segment be placed between each bend (Photo 35). There is some leniency with larger (i.e. 24-inch and greater) pipes, because they provide more space for ROVs to turn; but if anything sharper than a 45° elbow must be used in a layout, an additional access point should be placed at that location instead.

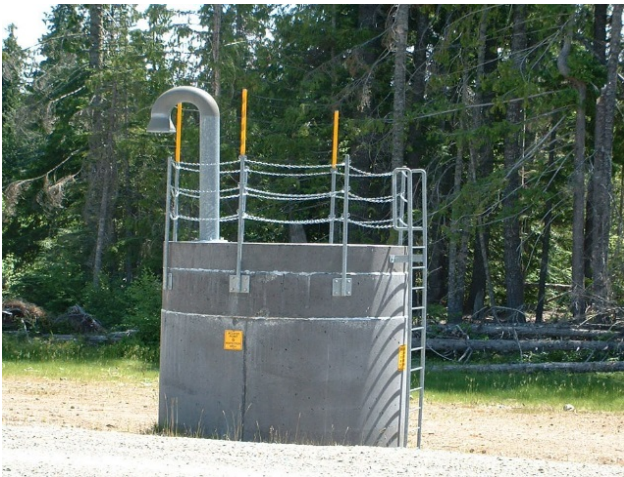
Photo 36 – An inspection well constructed to this height would create substantial friction on both the inspection and maintenance equipment.

Another way to address this issue is to minimize bends at the access point. For example, if an inspection well has been built at or above waist height, the angle created between the cable/hose reel and the manhole adds additional friction that can be avoided (Figure 2). Sometimes this is not feasible due to snow conditions or road access locations (Photo 36) [36], but where possible, access points should be relatively low to the ground to improve accessibility (Photo 37).

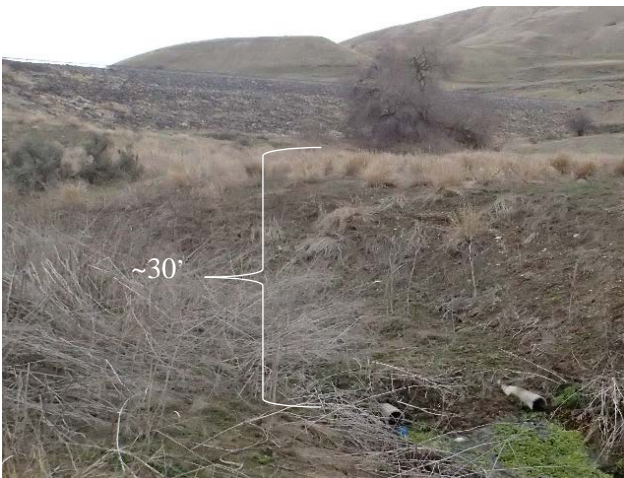
Photo 38 – These toe drains were buried almost thirty feet below the base of the toe, and would require significant excavation into the embankment to replace the drains.

Repairs can be expensive if the toe drain is not reasonably accessible by excavation (Photo 38 and Photo 39) [22]. Slip-lining is discouraged since this would interfere with the system’s ability to collect seepage. Therefore, while the required depth of a toe drain system is inevitably site specific, toe drains should be kept in relatively close proximity to the embankment surface, such that unnecessarily deep excavations into the downstream embankment will not be required.

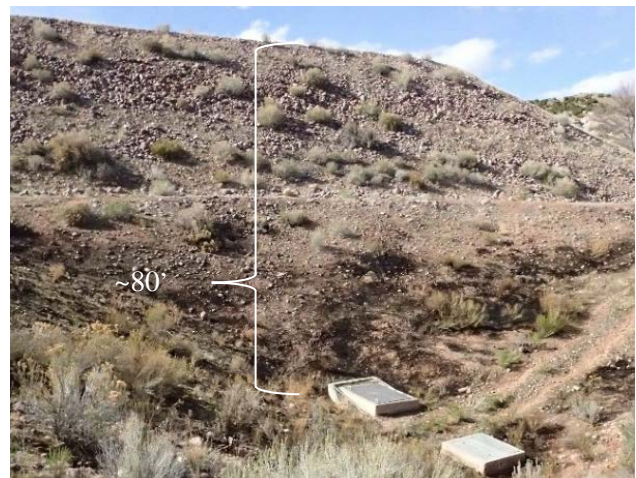
**Modifications** – It should be noted that while toe drains may have been initially designed and constructed correctly, modifications to the dam may have adverse effects on the system. For example, seismic stability or filter/seepage collection berms are often added to embankment toes to reduce the risk to the dam. However, when the existing toe drain system is left in place it ends up being buried far deeper than its original design (Photo 39). Not only does this make the drain less accessible for repairs or replacement, but it increases the overburden pressure on the pipe, which can lead to collapse (Photo 18, Photo 19, Photo 65, and Photo 74). Therefore, when making such modifications, an assessment should be made of the existing pipe’s ability to withstand the additional overburden. As necessary, it should be replaced with stronger pipe, relocated downstream, and/or supplemented with a more accessible drainage system.

Photo 39 – View of a seismic berm constructed over the existing toe drains, placing over 80’ of material above the drains.
