BLUFFDALE CITY ALTERNATE PAVEMENT METHODS
Project ID: CEEEn_CPST_003

A Capstone Project Final Report

Addison Mitton
City of Bluffdale

Department of Civil and Construction Engineering
Brigham Young University
April 17, 2024

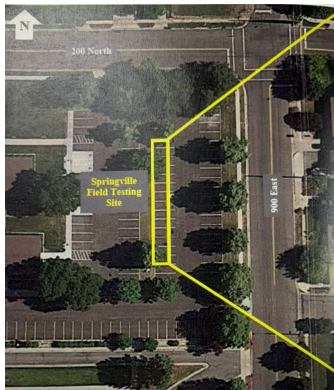
Figure 1.1.2: Aerial View

Figures 1.1.2 and 1.1.3 illustrates a parking lot at 200 N and 900 E in Springville, UT.

In 2014 this fiber reinforced asphalt was installed in Springville, Utah in a church parking lot. As pictured, the asphalt is experiencing extreme discoloration and longitudinal cracking, as is to be expected for a pavement in its tenth year. Seals have been applied to the pavement in order to extend its lifespan.

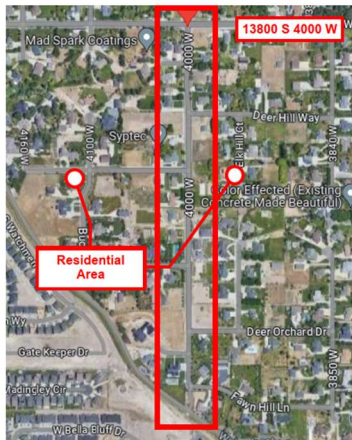
Figure 2.2.1: Aerial view

The roadway at W13800 S and 4000 W is in a low-traffic residential area. The roadway has multiple driveways and residential roads intersecting the segment. The main concerns with this segment are its extensive cracking and distortion, closely spaced longitudinal and transverse cracks, raveling, and significant surface wear.

Figures 2.2.1 and 2.2.2 show Site 2 (13800 S 4000 W) in Bluffdale City.

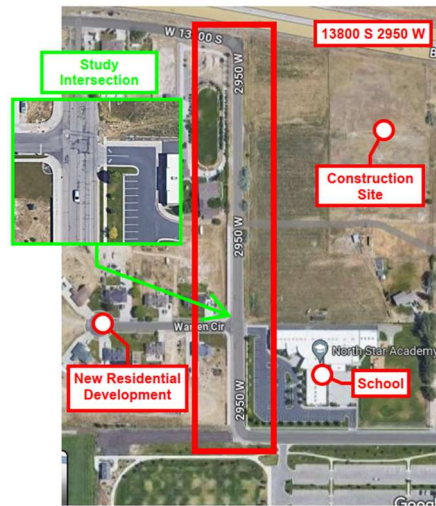
Figure 2.3.1: Aerial view of 13800 S 2950 W

Figure 2.3.1 presents an aerial view of the studied section.

The site, classified as Paser 2 (very poor), shows significant road deterioration, posing substantial risks to road users. Over 25% of the surface features alligator cracking and severe distortions deeper than 2 inches, which undermine the road's structural integrity. Poorly patched areas and potholes are prevalent, especially around a centrally located manhole. These conditions, worsened by nearby construction and proximity to a school, severely affect traffic flow and increase accident risks. Figure 2.3.2 illustrates the road's poor condition with images of the extensive damage.
